<b>TO:</b> Allan Williams Highland Park Environmental Commission  <b>FROM:</b> John Poserina, Project Manager	<b>DATE:</b> 08/10/2018  <b>PROJECT NO.:</b> 3480180606 <b>PROJ. NAME:</b> Honeywell Highland Park <b>SUBJECT:</b> Construction Air Monitoring Data for week of 062518 to 062918 Former Midland Ross Facility, SRP PI#018773 Highland Park, New Jersey
---	--

# **AIR MONITORING STATION LOCATIONS**

## **CONSTRUCTION AIR MONITORING DATA**

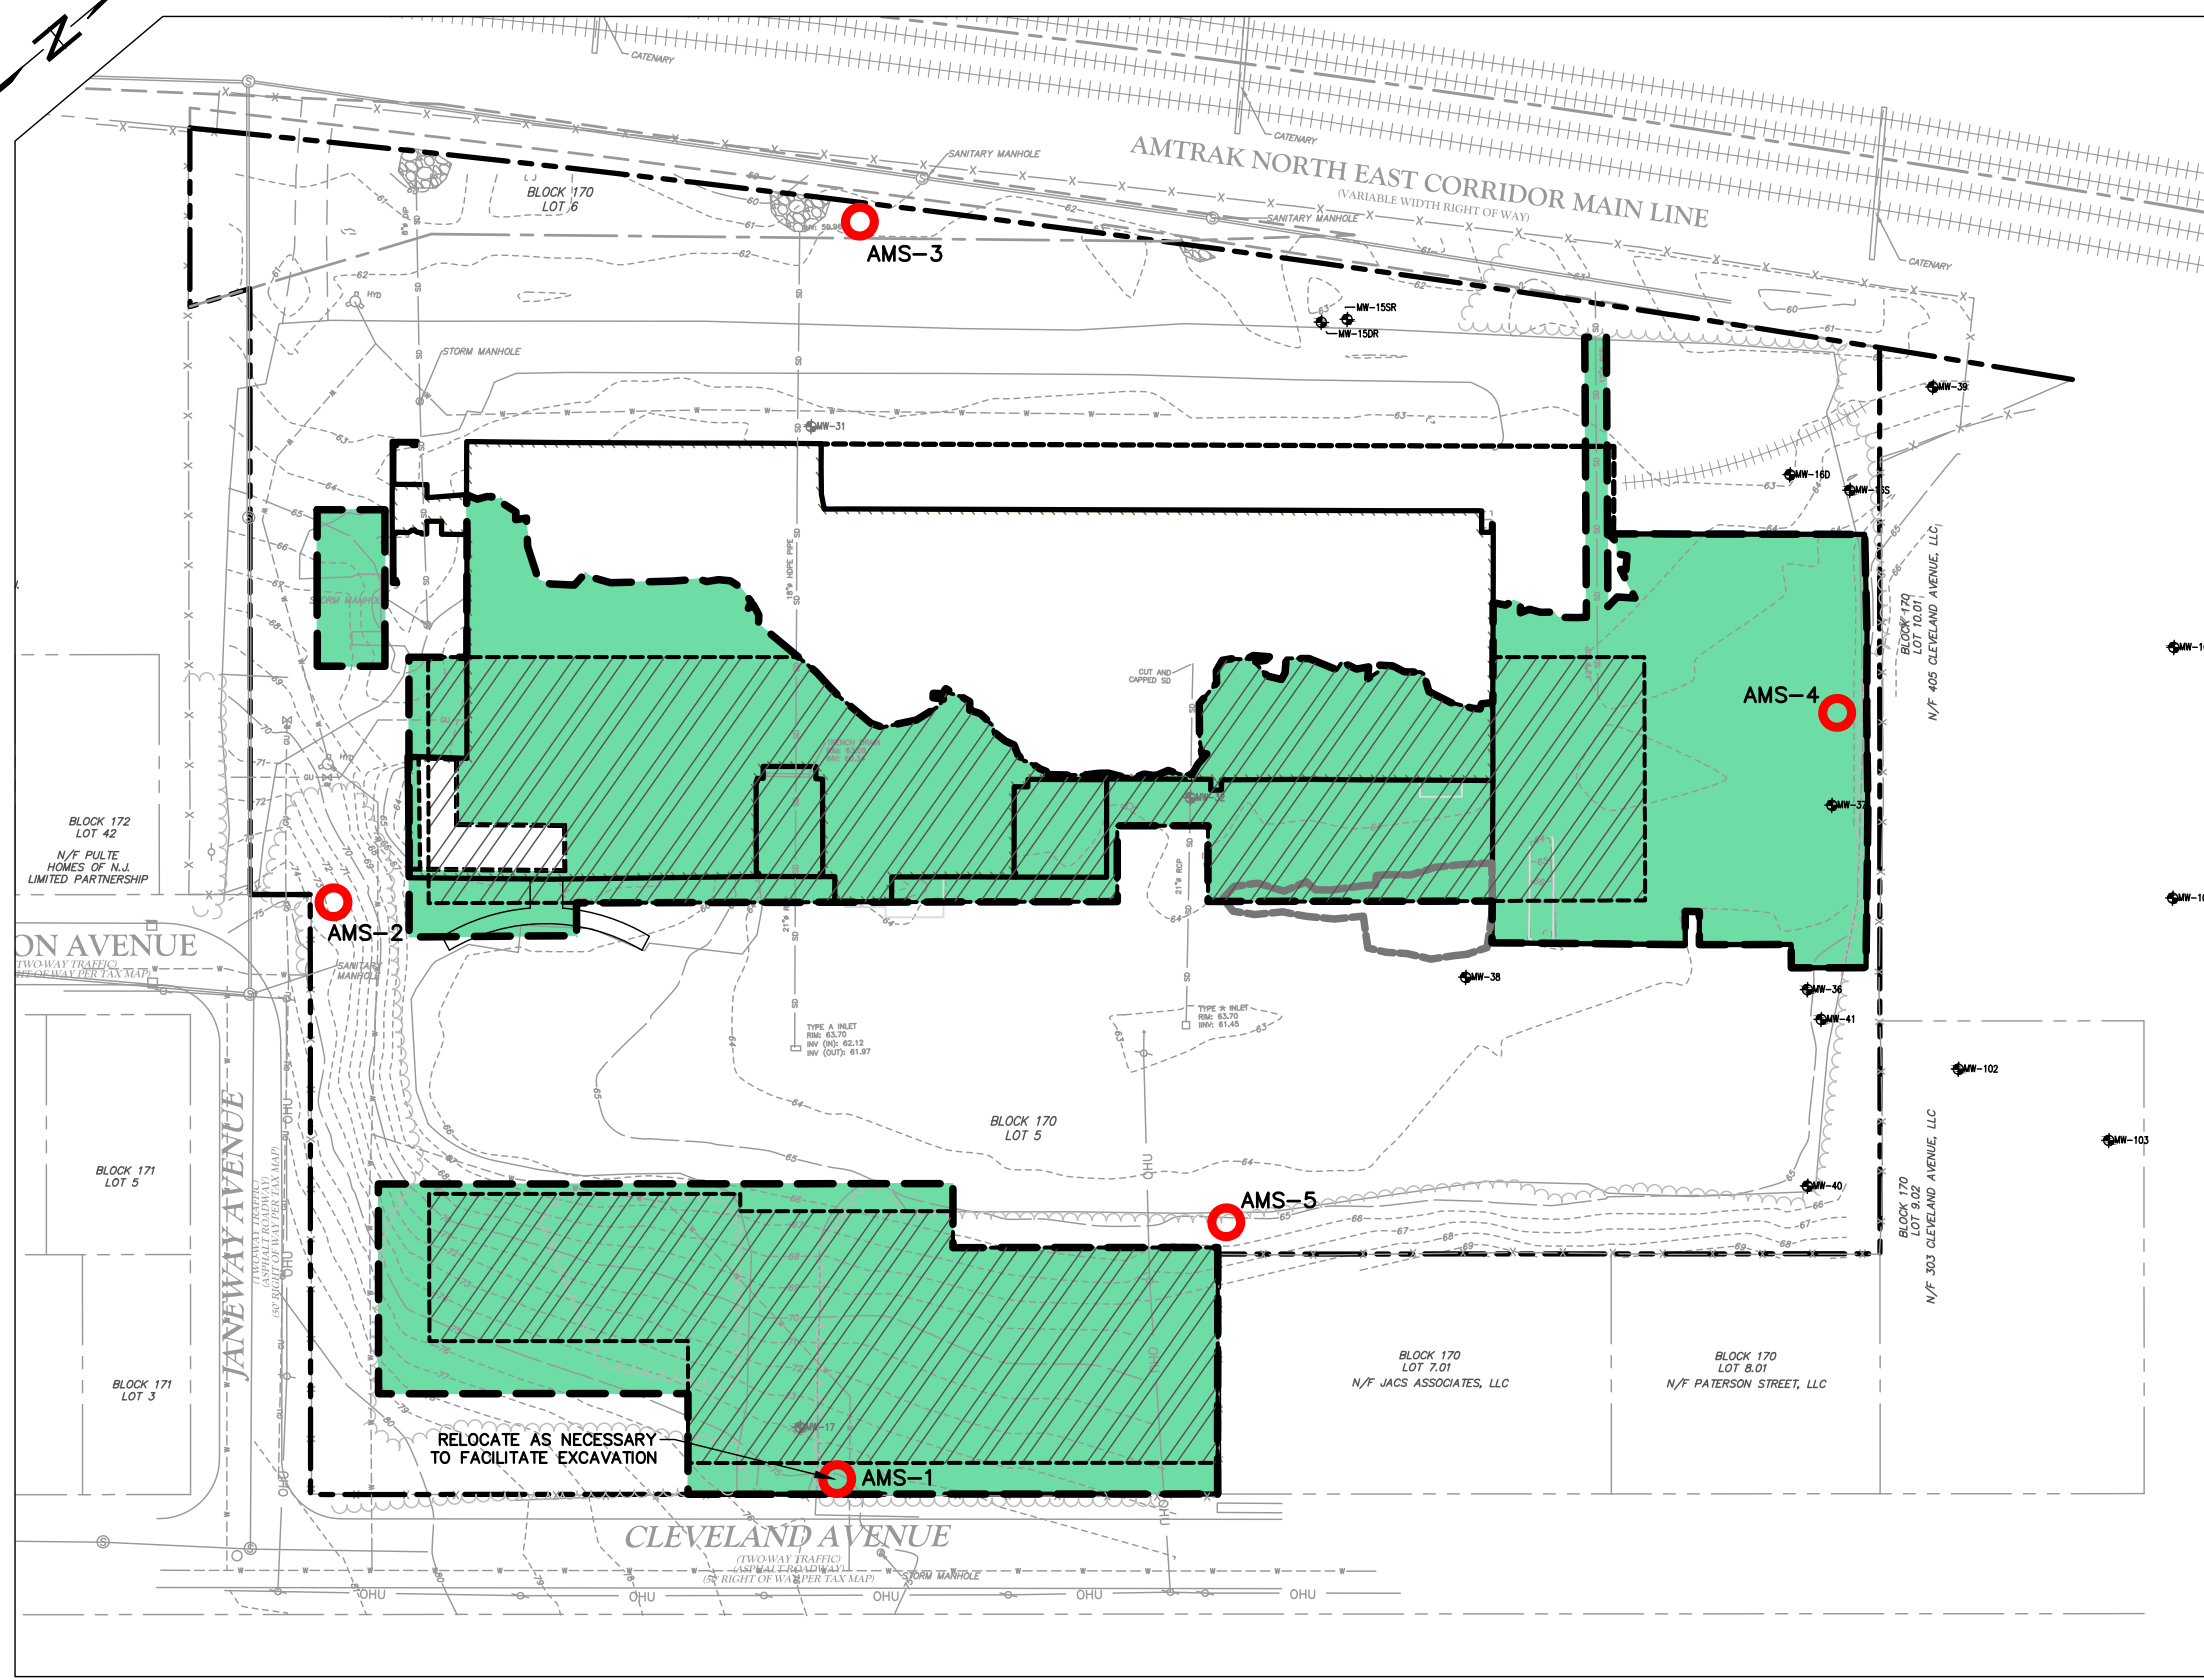
**FIGURE 1**  
PROPOSED PERIMETER AIR MONITORING STATION LOCATION  
HONEYWELL - FORMER MIDLAND-ROSS SITE  
HIGHLAND PARK, NEW JERSEY

- PROPERTY BOUNDARY (FORMER MIDLAND-ROSS FACILITY)
- PROPOSED EXCAVATION AREA (AOC MR-8)
- FORMER JANEWAY-CARPENTER BUILDING CONCRETE SLAB REMOVAL AREA
- AMS-1 PROPOSED AIR MONITORING STATION LOCATION
