LETTER OF TRANSMITTAL

TO: Allan Williams Highland Park Environmental Commission FROM: John Poserina, Project Manager	DATE: 09/10/2018 PROJECT NO.: 3480180606 PROJ. NAME: Honeywell Highland Park SUBJECT: Construction Air Monitoring Data for week of 082018 to 082418 Former Midland Ross Facility, SRP PI#018773 Highland Park, New Jersey
---	--

FIGURE 1
PROPOSED PERIMETER AIR MONITORING STATION LOCATION
HONEYWELL - FORMER MIDLAND-ROSS SITE
HIGHLAND PARK, NEW JERSEY

CONSTRUCTION AIR MONITORING DATA

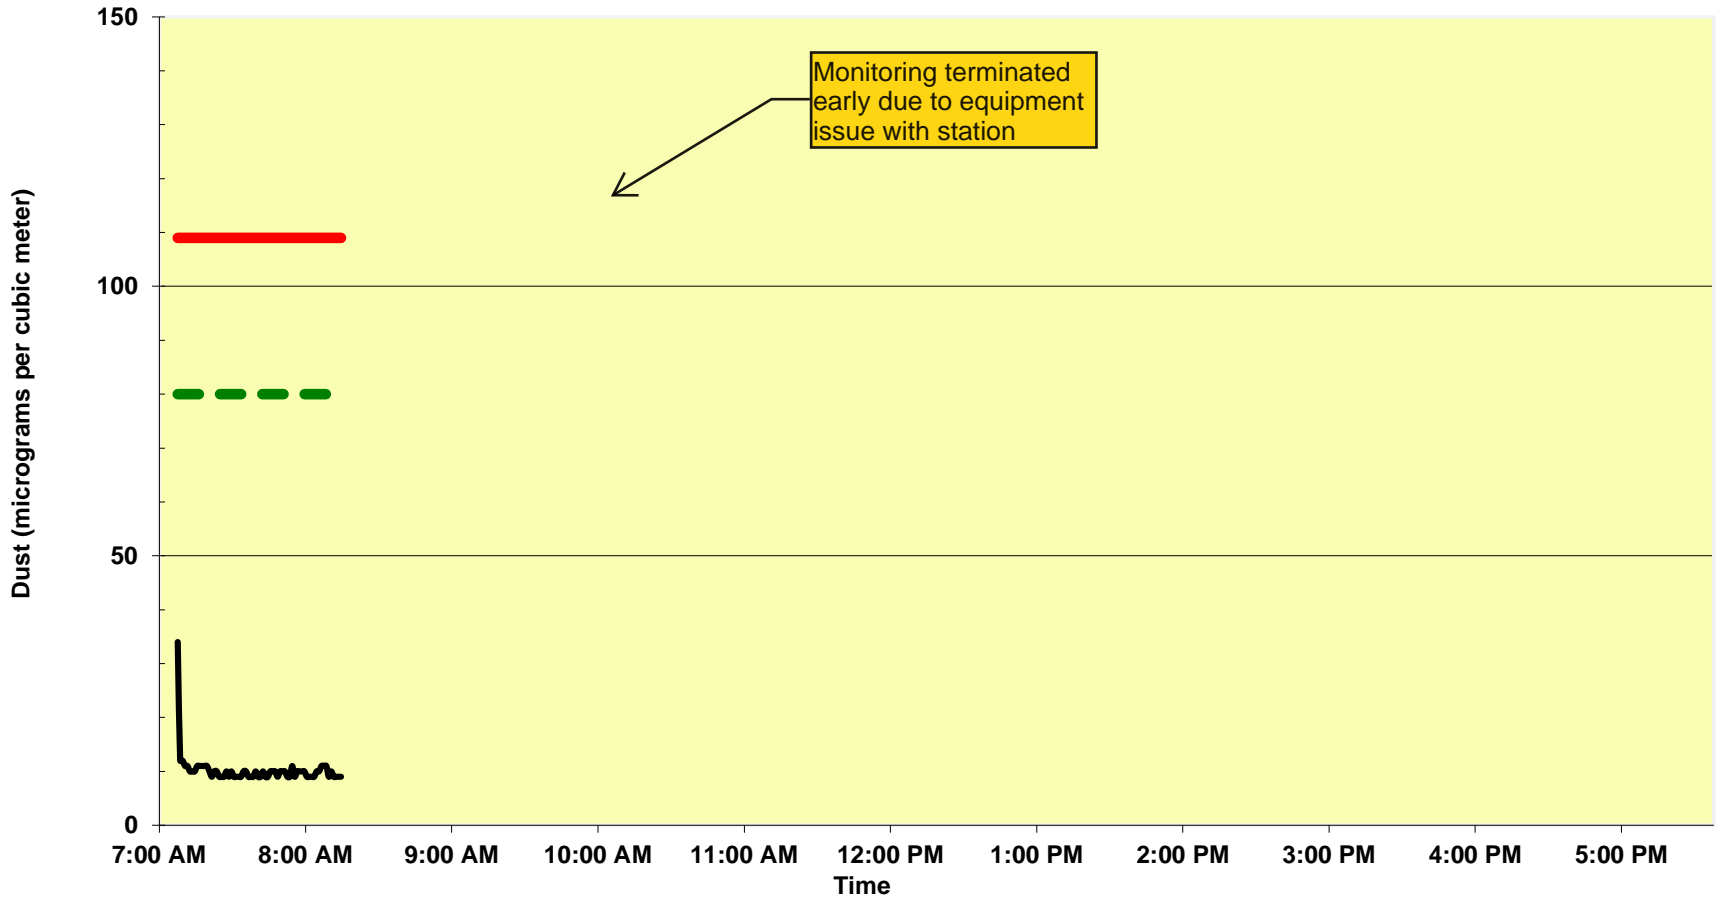
**Former Midland-Ross Site
Highland Park, New Jersey
Dust Monitoring Results
Air Monitor 1 8/20/2018**

Air Monitoring Results

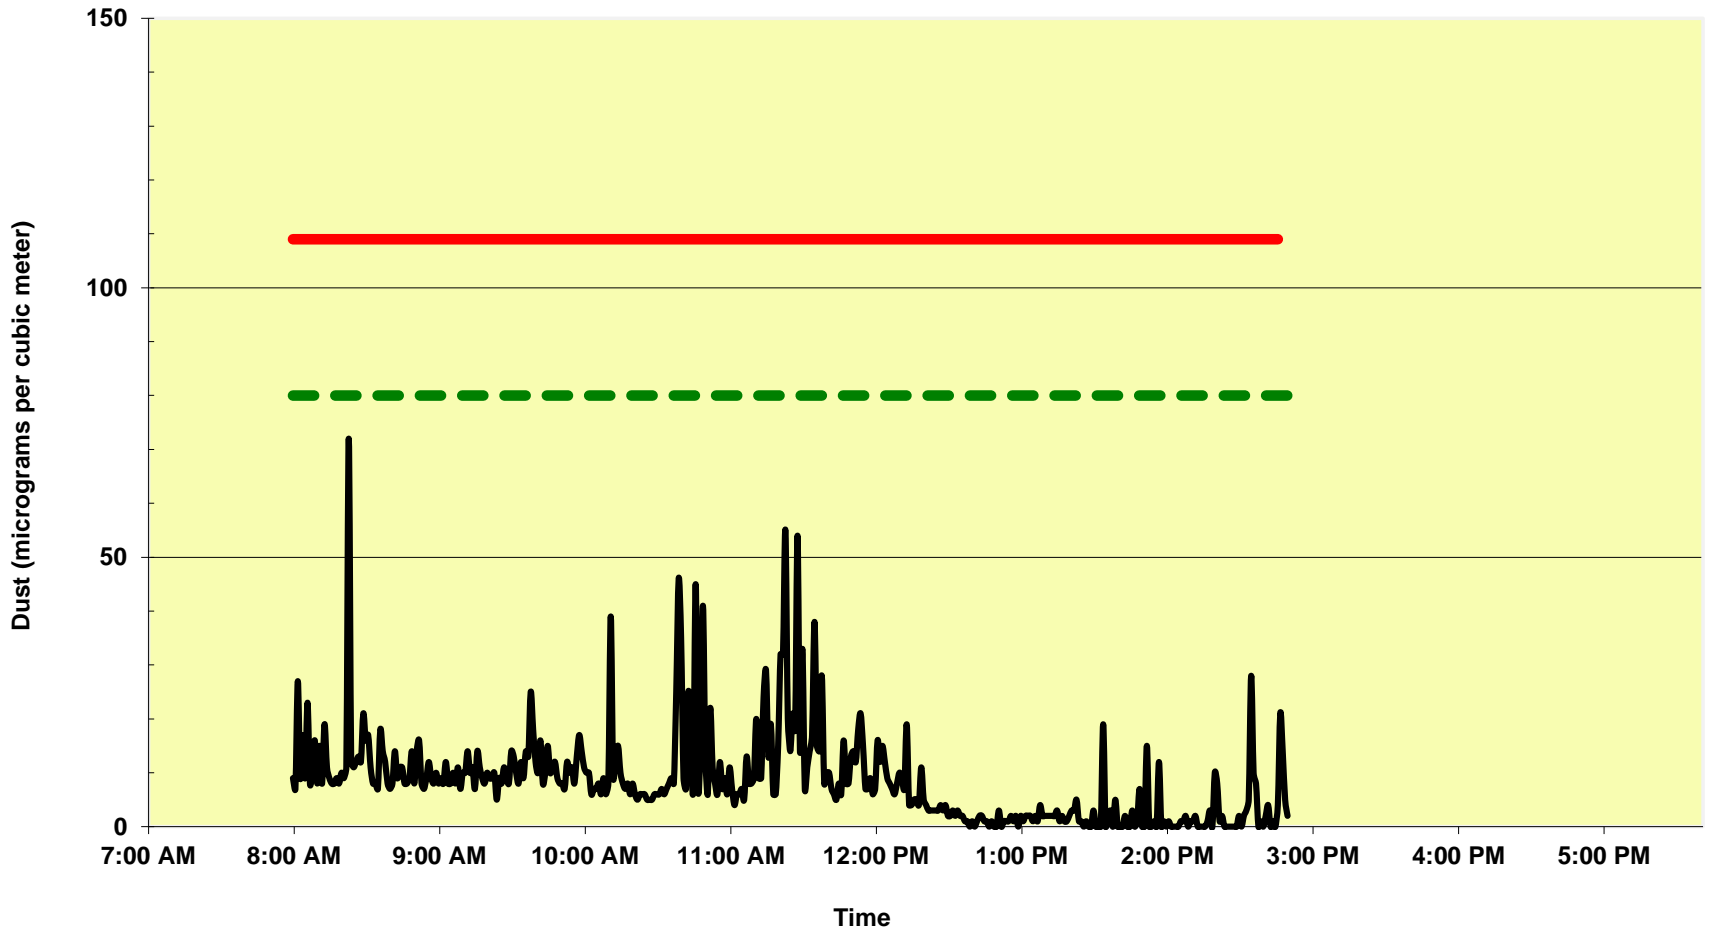
**Former Midland-Ross Site
Highland Park, New Jersey
Dust Monitoring Results
Air Monitor 2 8/20/2018**

Air Monitoring Results

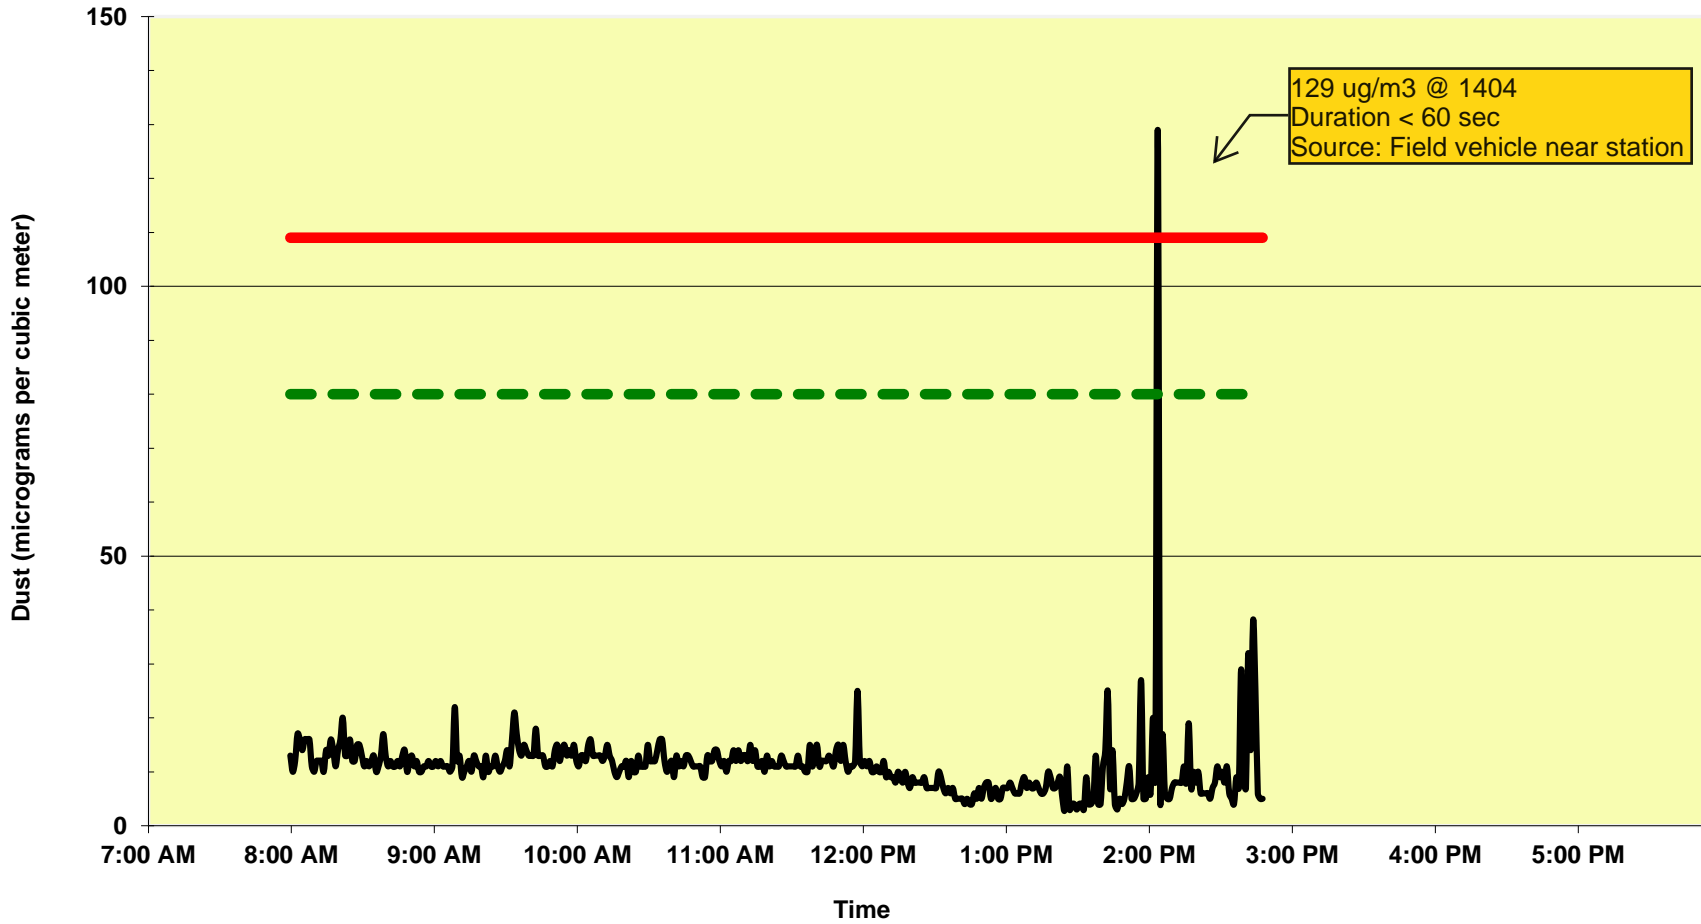
**Former Midland-Ross Site
Highland Park, New Jersey
Dust Monitoring Results
Air Monitor 3 8/20/2018**

Air Monitoring Results

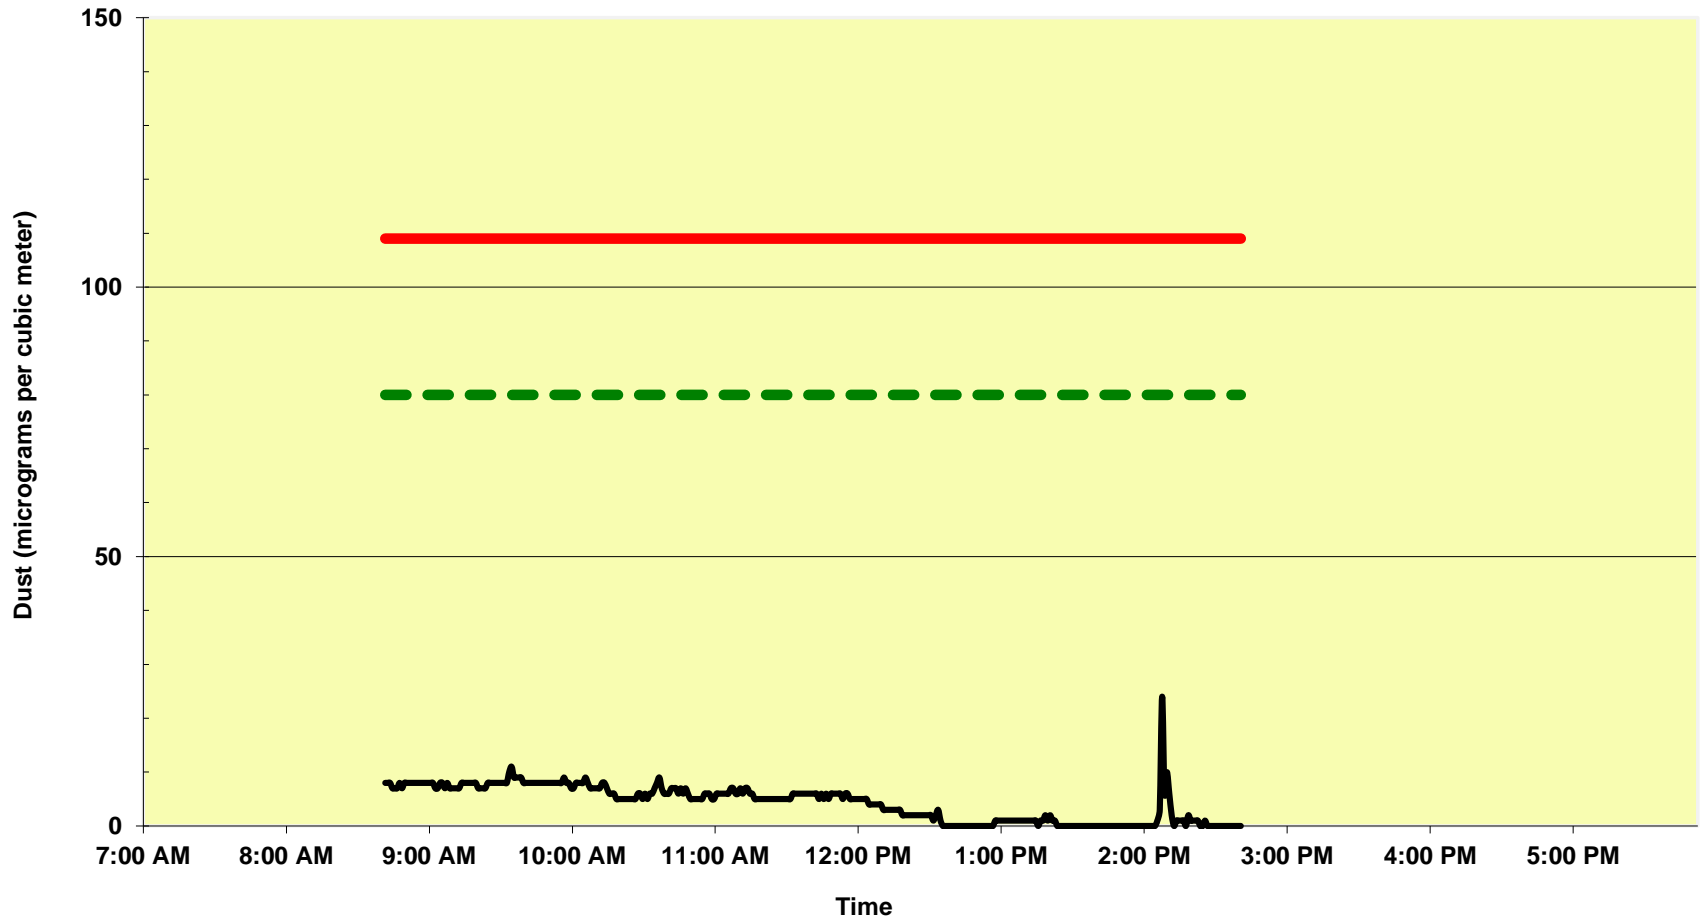
**Former Midland-Ross Site
Highland Park, New Jersey
Dust Monitoring Results
Air Monitor 4 8/20/2018**

Air Monitoring Results

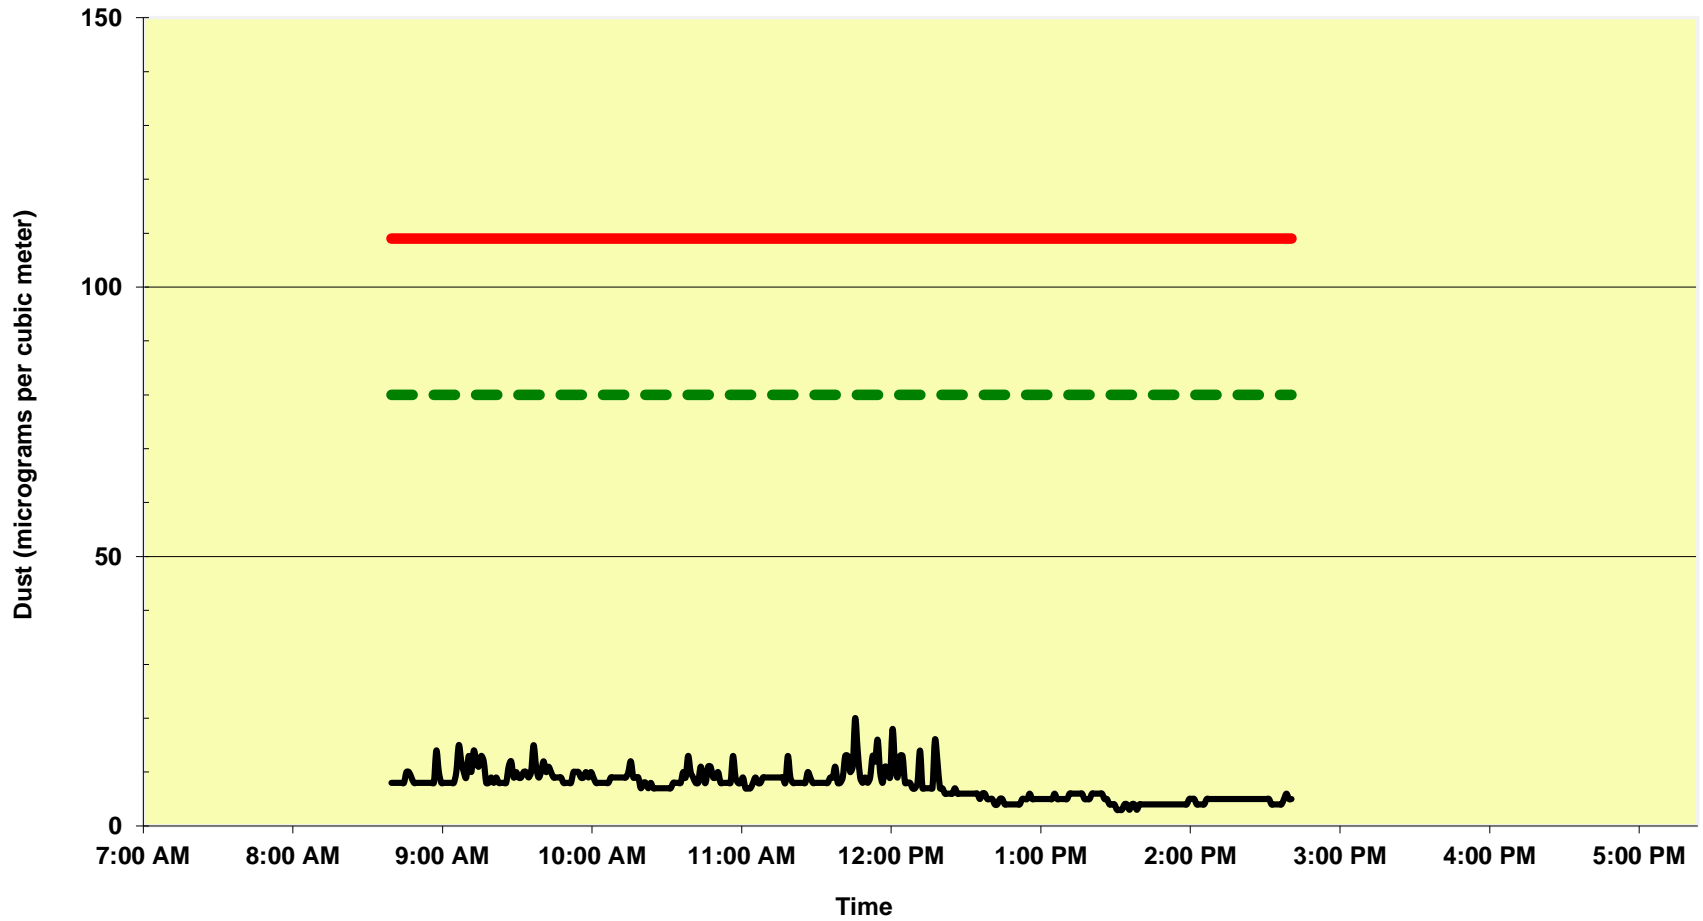
**Former Midland-Ross Site
Highland Park, New Jersey
Dust Monitoring Results
Air Monitor 5 8/20/2018**

Air Monitoring Results

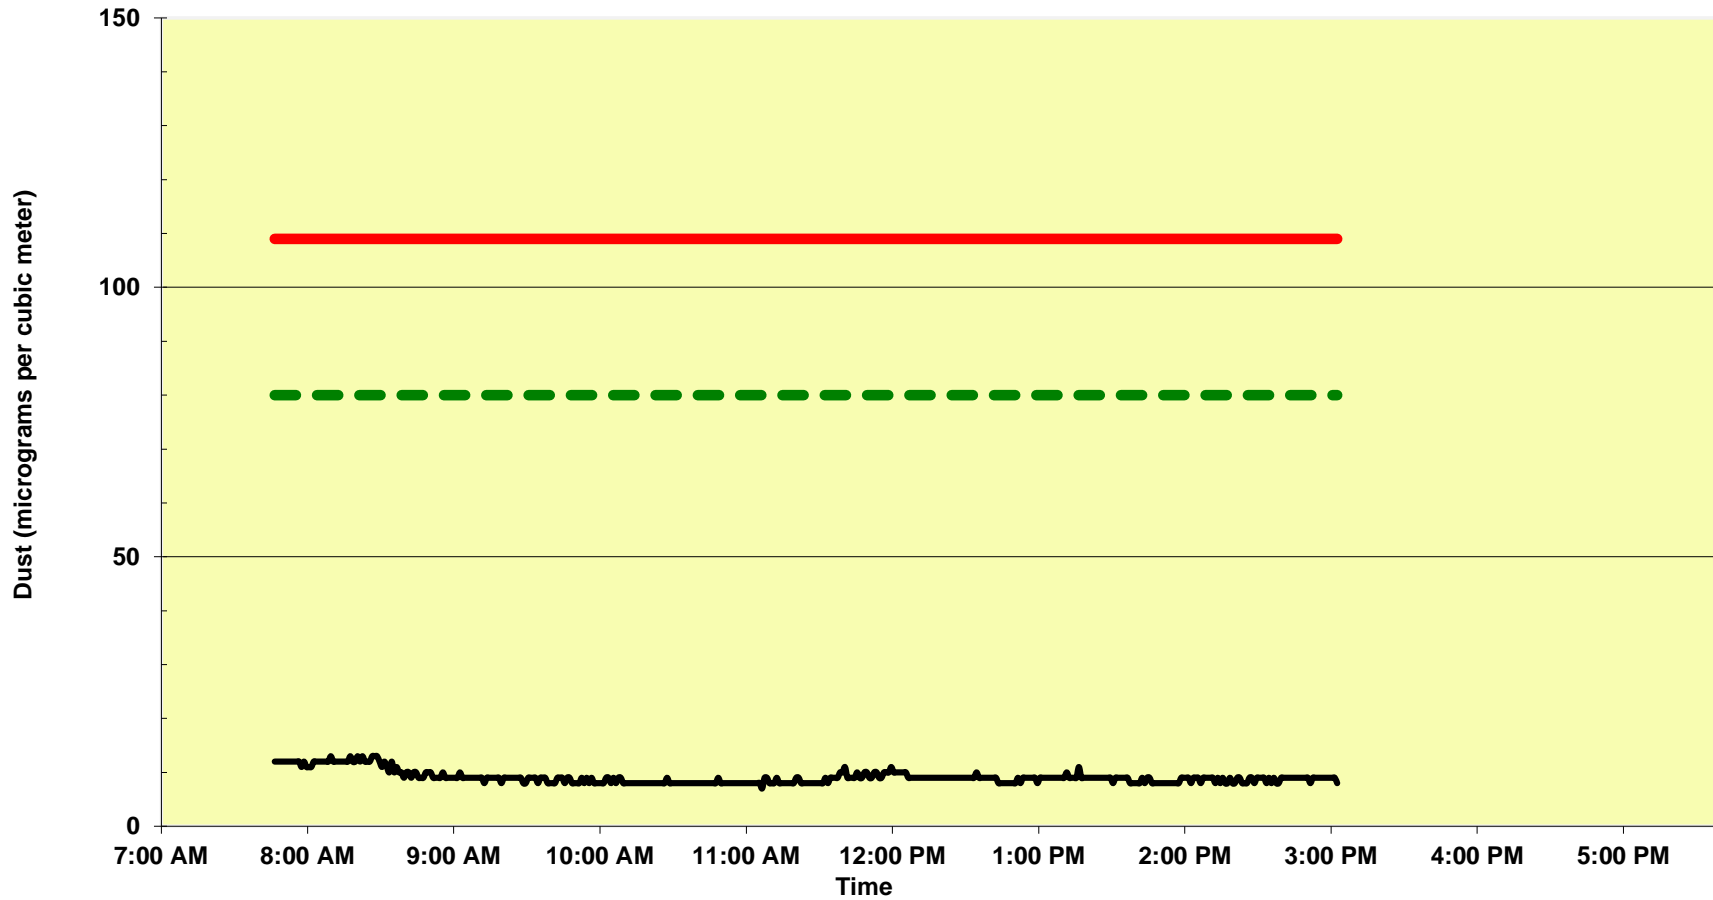
**Former Midland-Ross Site
Highland Park, New Jersey
Dust Monitoring Results
Air Monitor 1 8/21/2018**

Air Monitoring Results

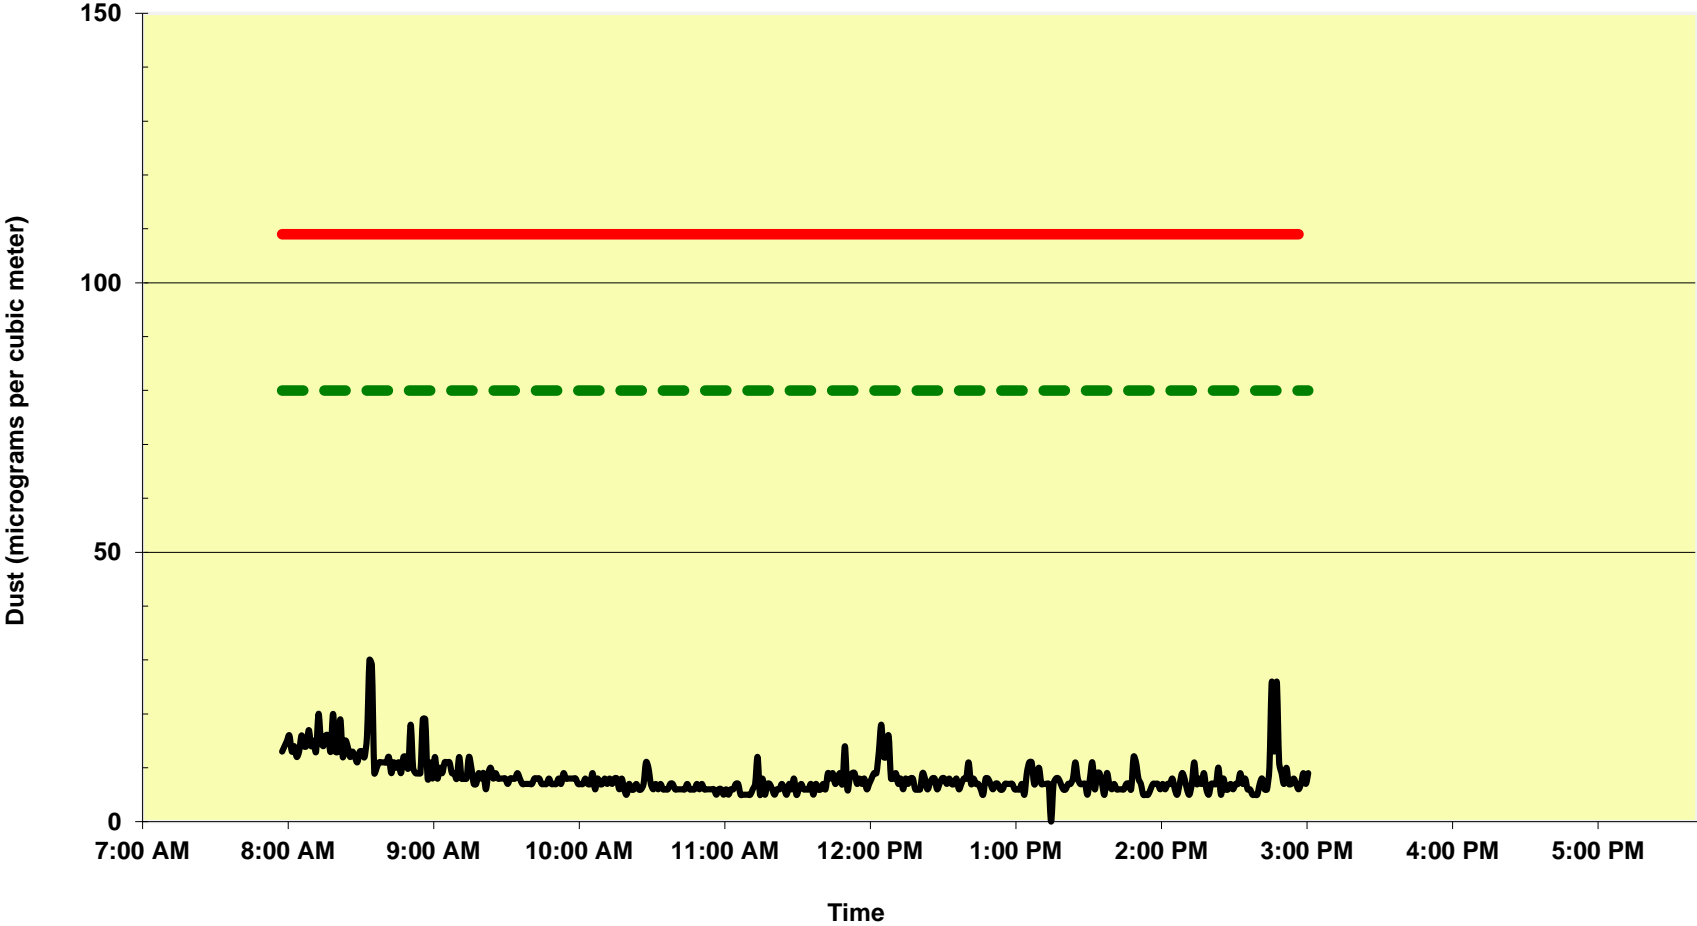
**Former Midland-Ross Site
Highland Park, New Jersey
Dust Monitoring Results
Air Monitor 2 8/21/2018**

Air Monitoring Results

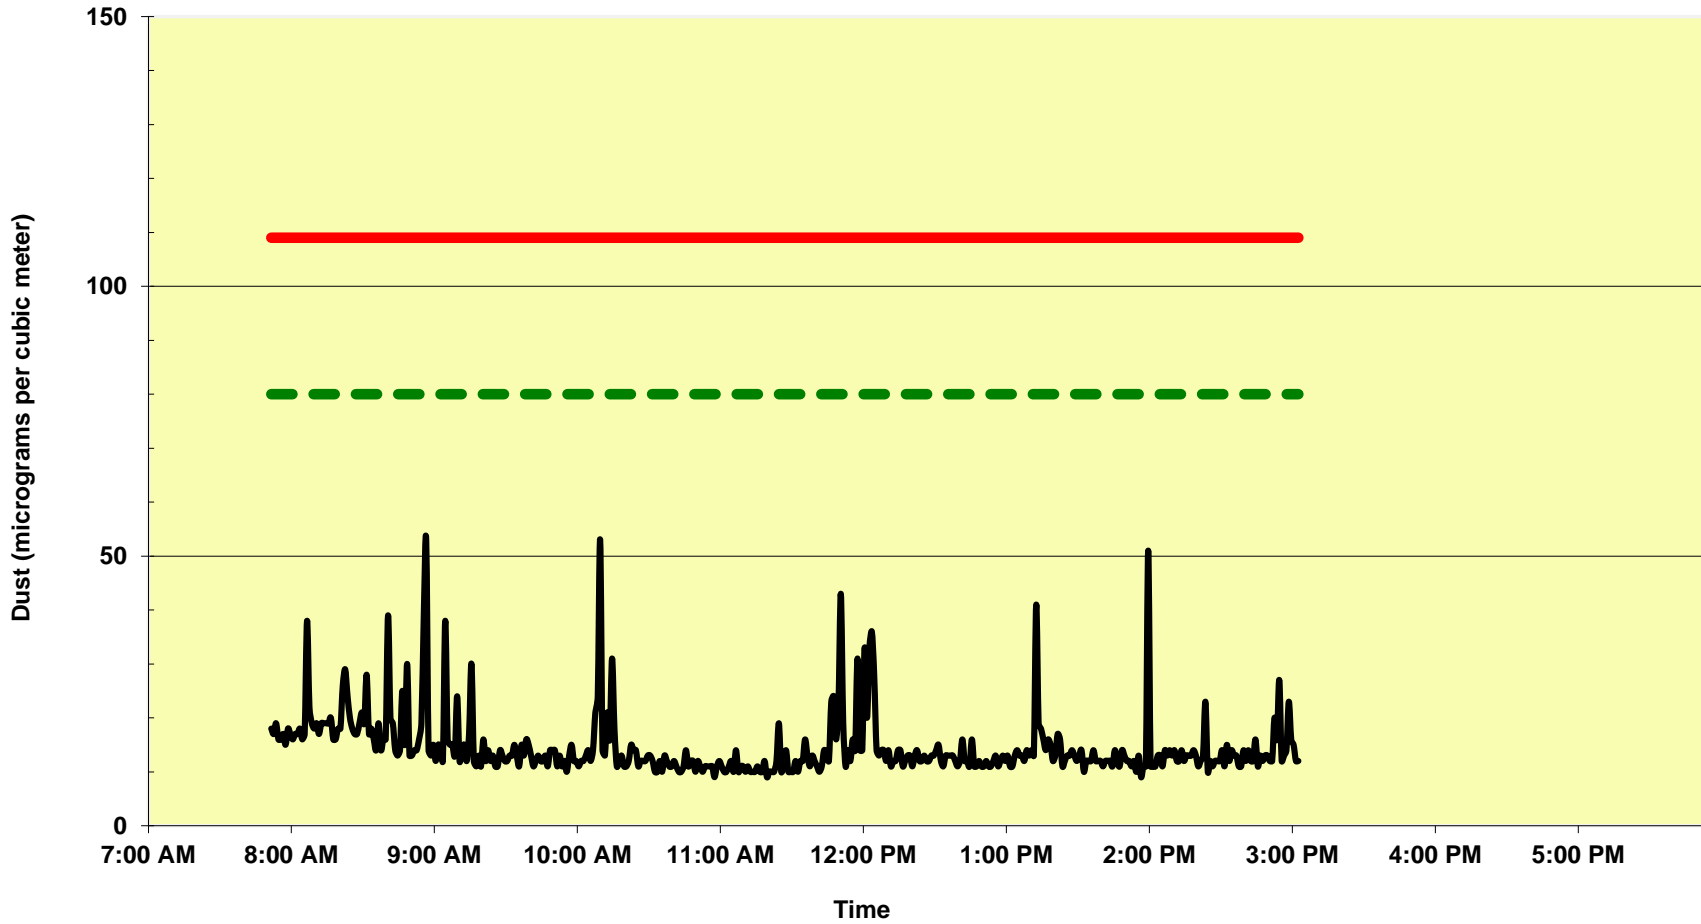
**Former Midland-Ross Site
Highland Park, New Jersey
Dust Monitoring Results
Air Monitor 3 8/21/2018**

Air Monitoring Results

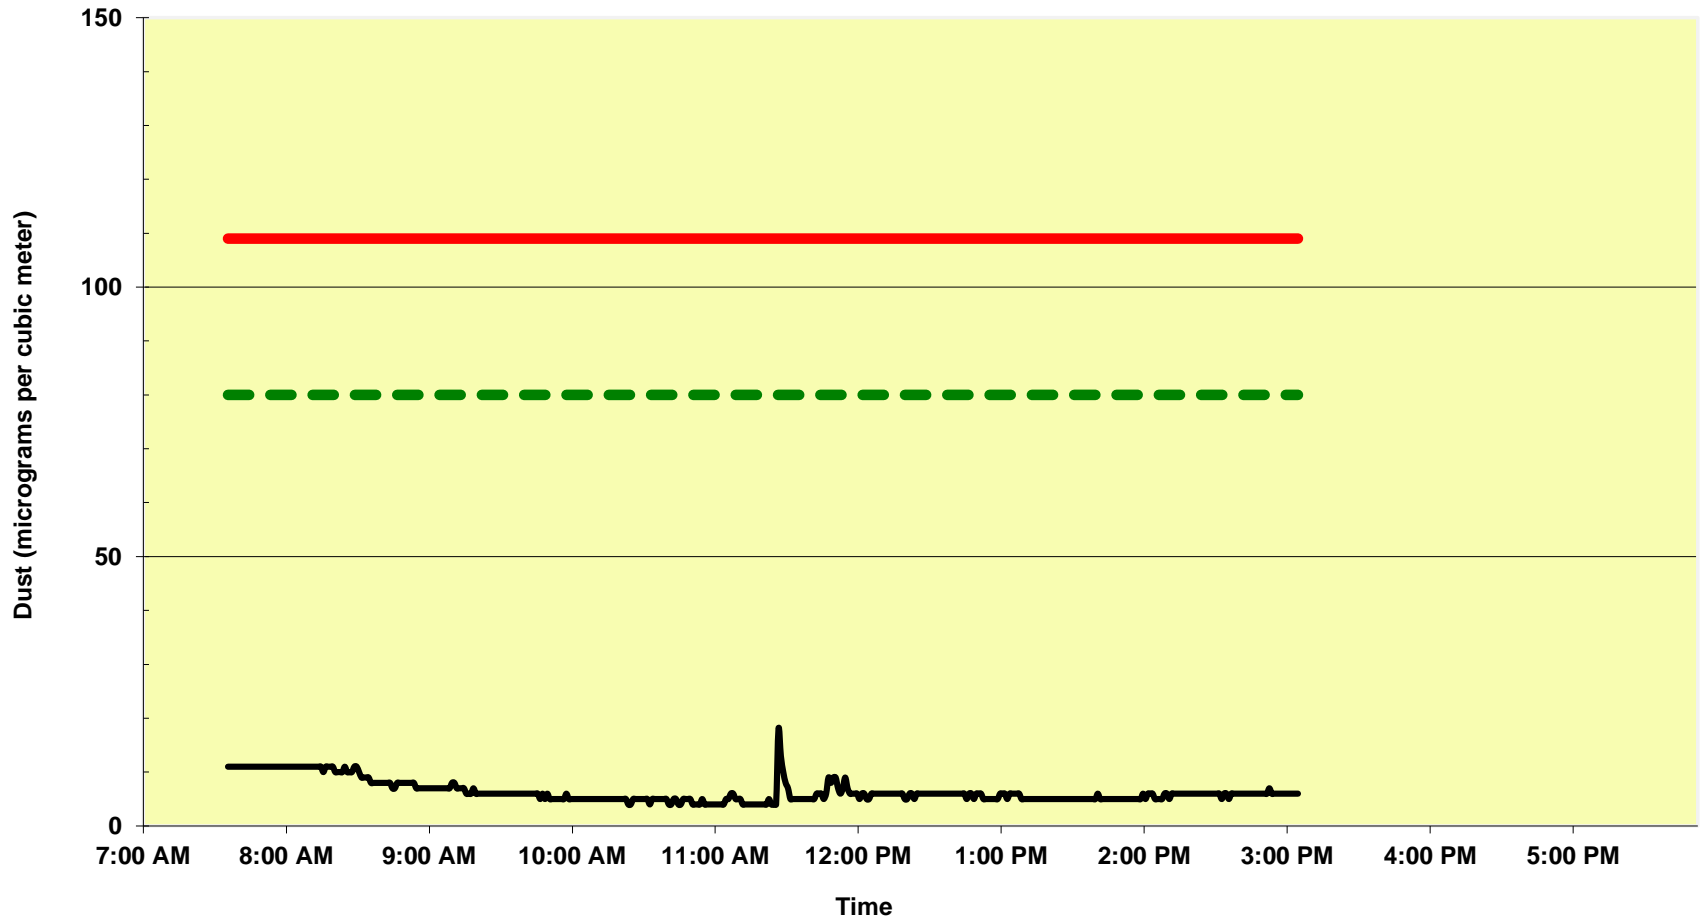
**Former Midland-Ross Site
Highland Park, New Jersey
Dust Monitoring Results
Air Monitor 4 8/21/2018**

Air Monitoring Results

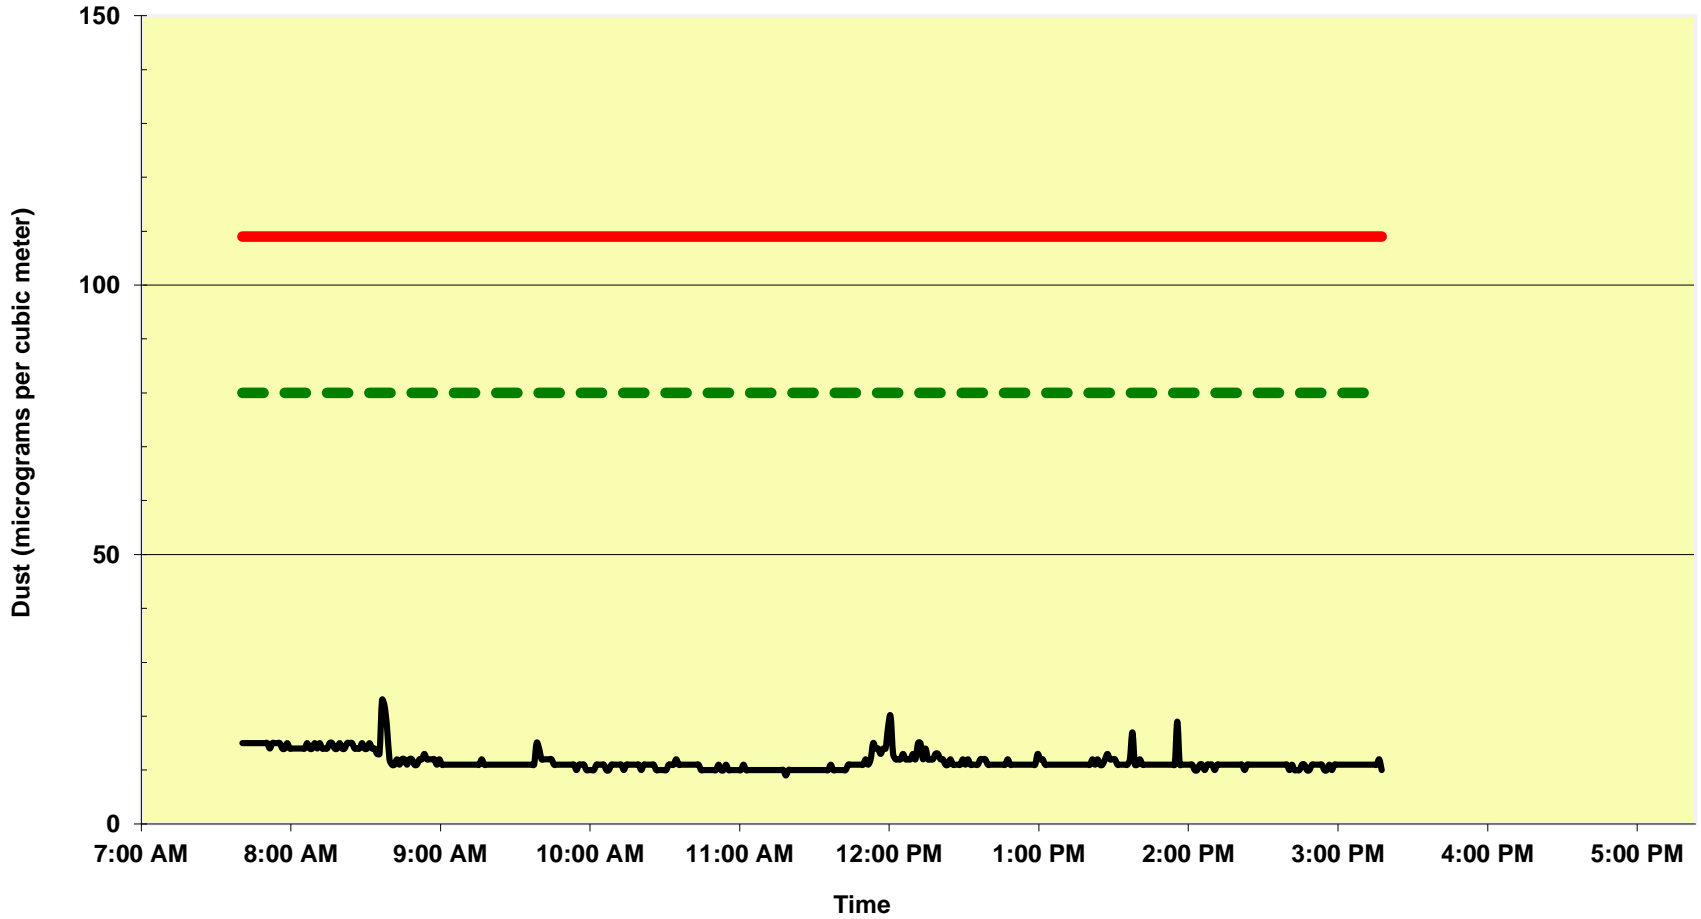
**Former Midland-Ross Site
Highland Park, New Jersey
Dust Monitoring Results
Air Monitor 5 8/21/2018**

Air Monitoring Results

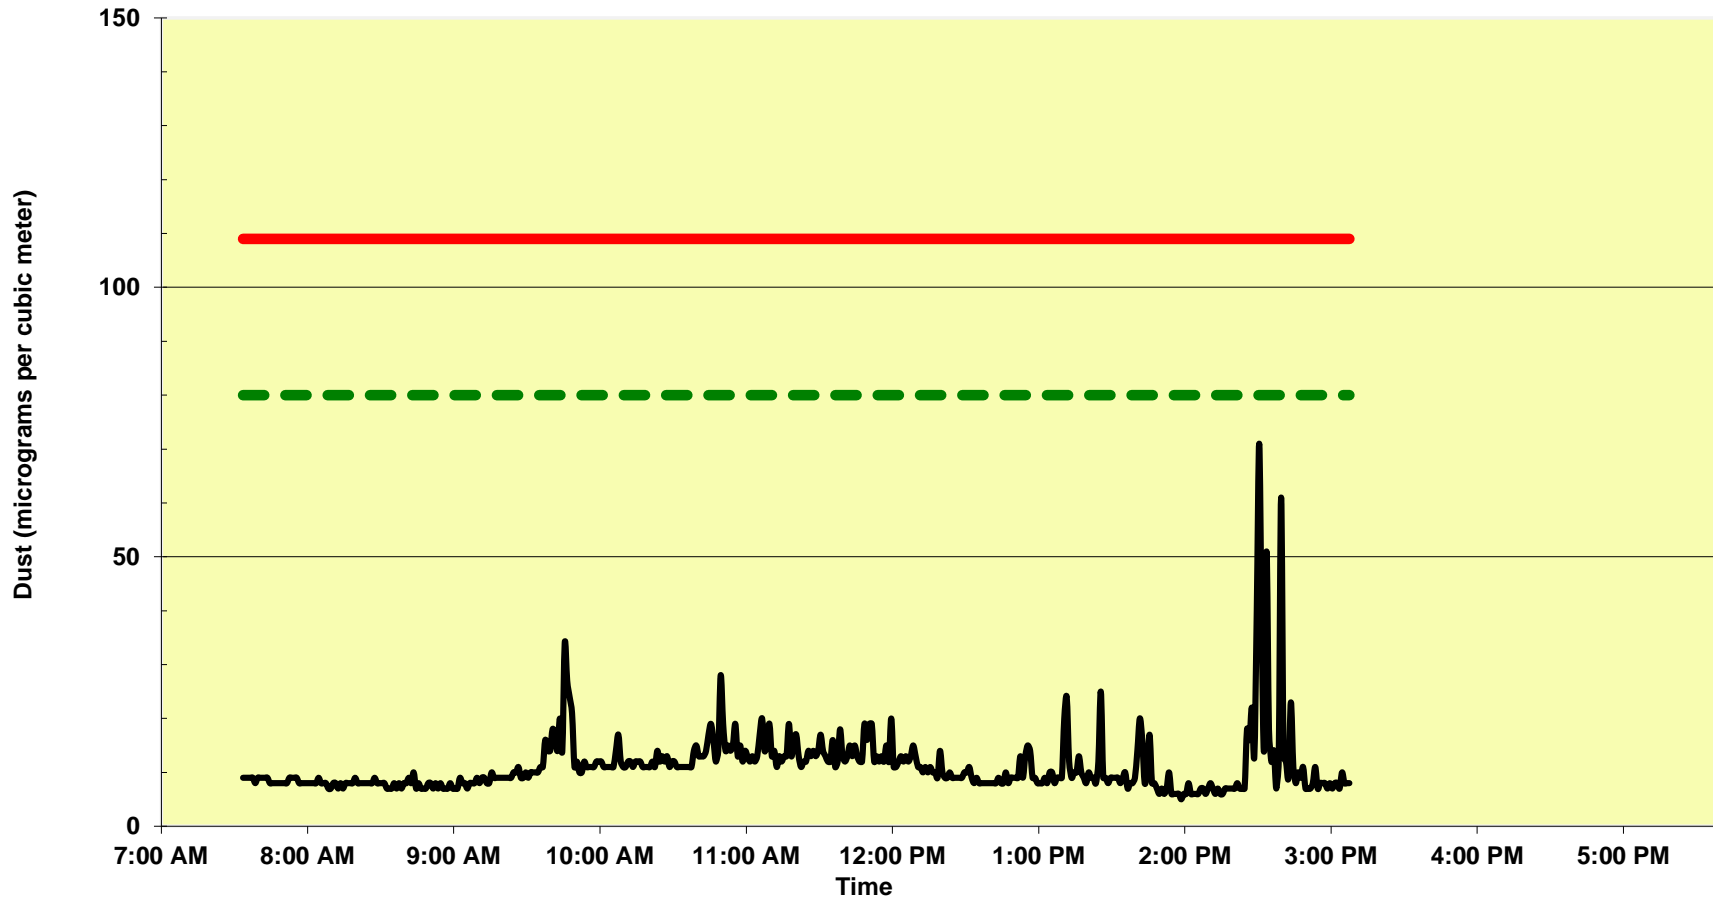
**Former Midland-Ross Site
Highland Park, New Jersey
Dust Monitoring Results
Air Monitor 1 8/22/2018**

Air Monitoring Results

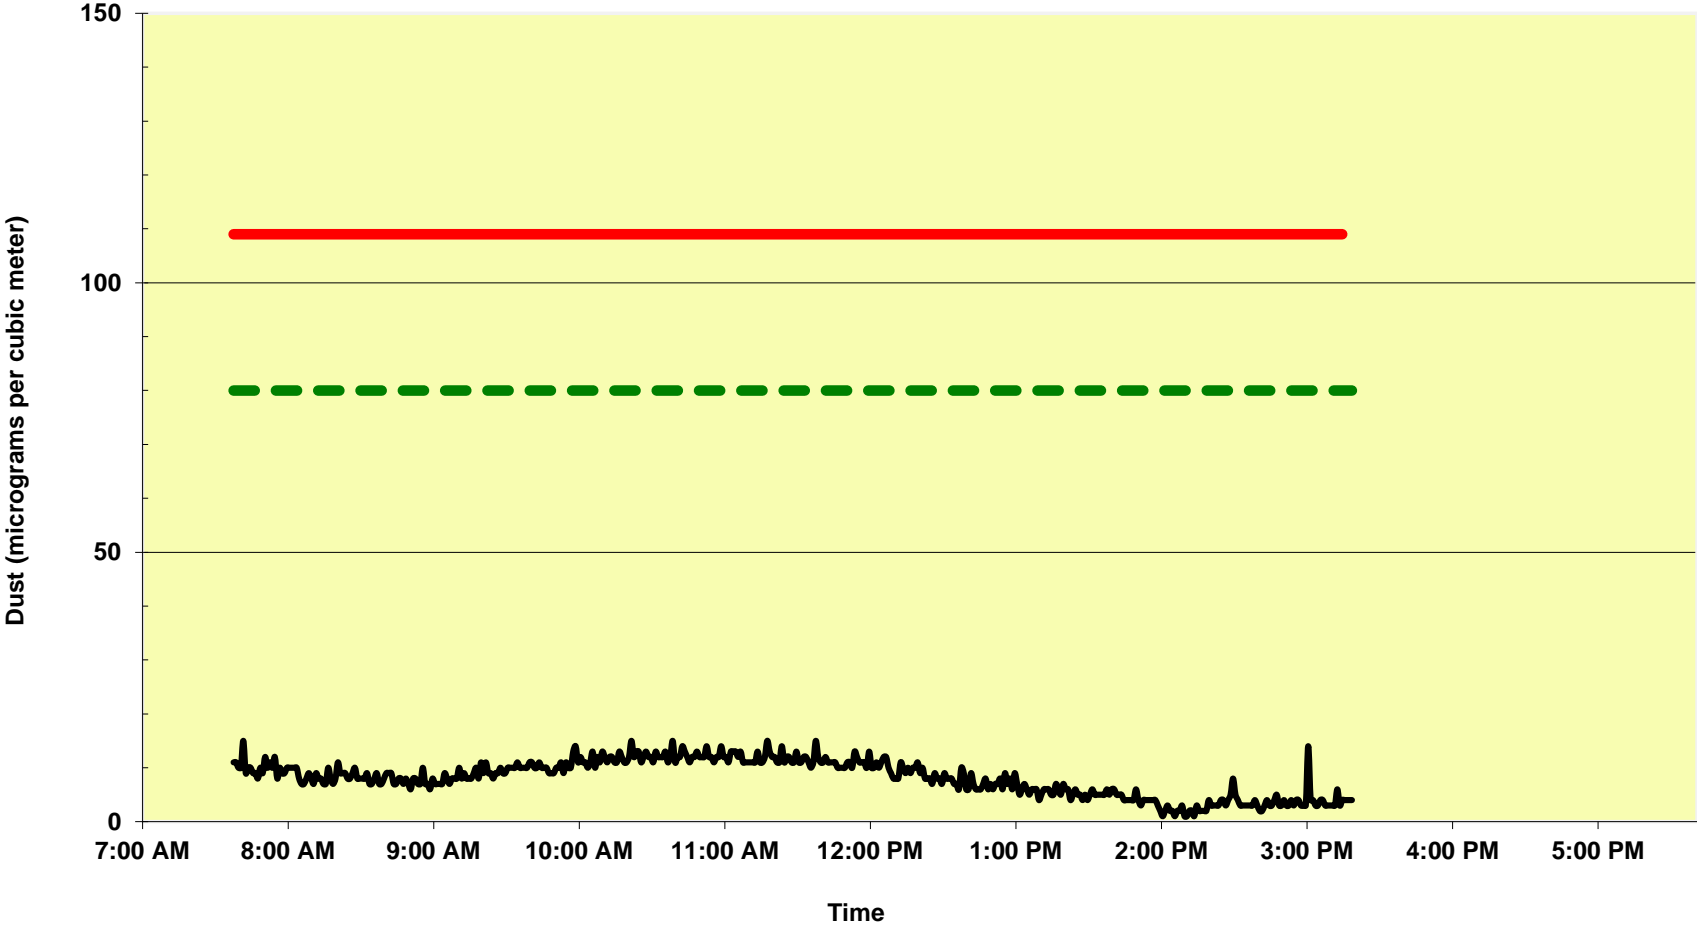
**Former Midland-Ross Site
Highland Park, New Jersey
Dust Monitoring Results
Air Monitor 2 8/22/2018**

Air Monitoring Results

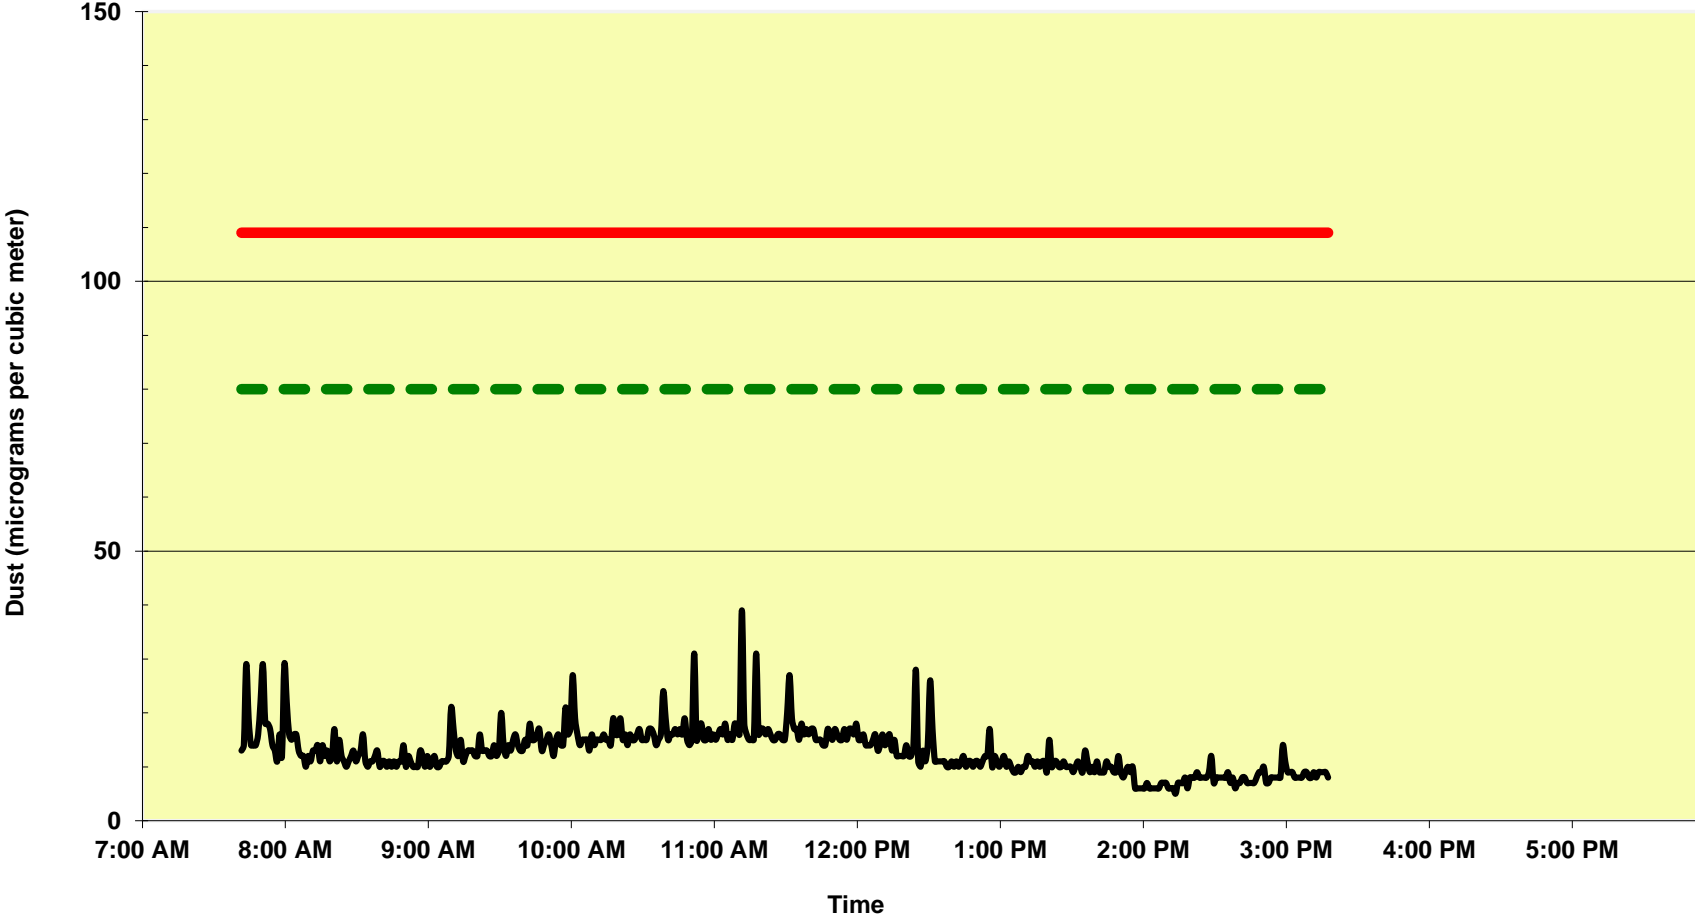
**Former Midland-Ross Site
Highland Park, New Jersey
Dust Monitoring Results
Air Monitor 3 8/22/2018**

Air Monitoring Results

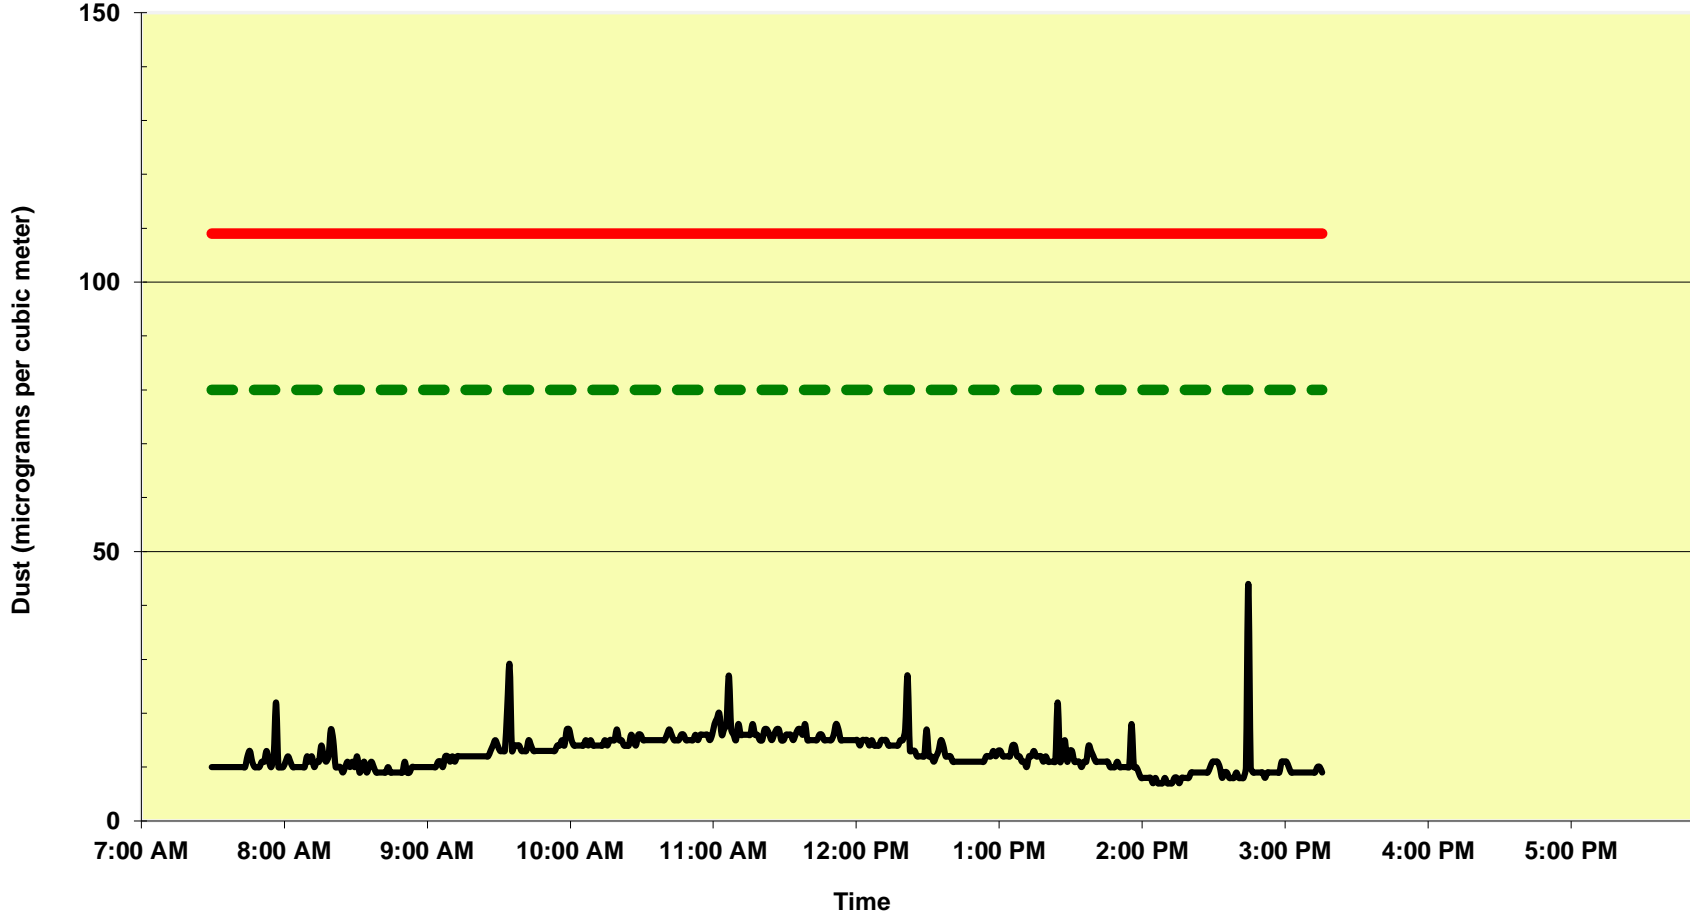
**Former Midland-Ross Site
Highland Park, New Jersey
Dust Monitoring Results
Air Monitor 4 8/22/2018**

Air Monitoring Results
