LETTER OF TRANSMITTAL

TO: Allan Williams Highland Park Environmental Commission FROM: John Poserina, Project Manager	DATE: 09/10/2018 PROJECT NO.: 3480180606 PROJ. NAME: Honeywell Highland Park SUBJECT: Construction Air Monitoring Data for week of 082018 to 082418 Former Midland Ross Facility, SRP PI#018773 Highland Park, New Jersey
---	--

FIGURE 1
PROPOSED PERIMETER AIR MONITORING STATION LOCATION
HONEYWELL - FORMER MIDLAND-ROSS SITE
HIGHLAND PARK, NEW JERSEY

CONSTRUCTION AIR MONITORING DATA

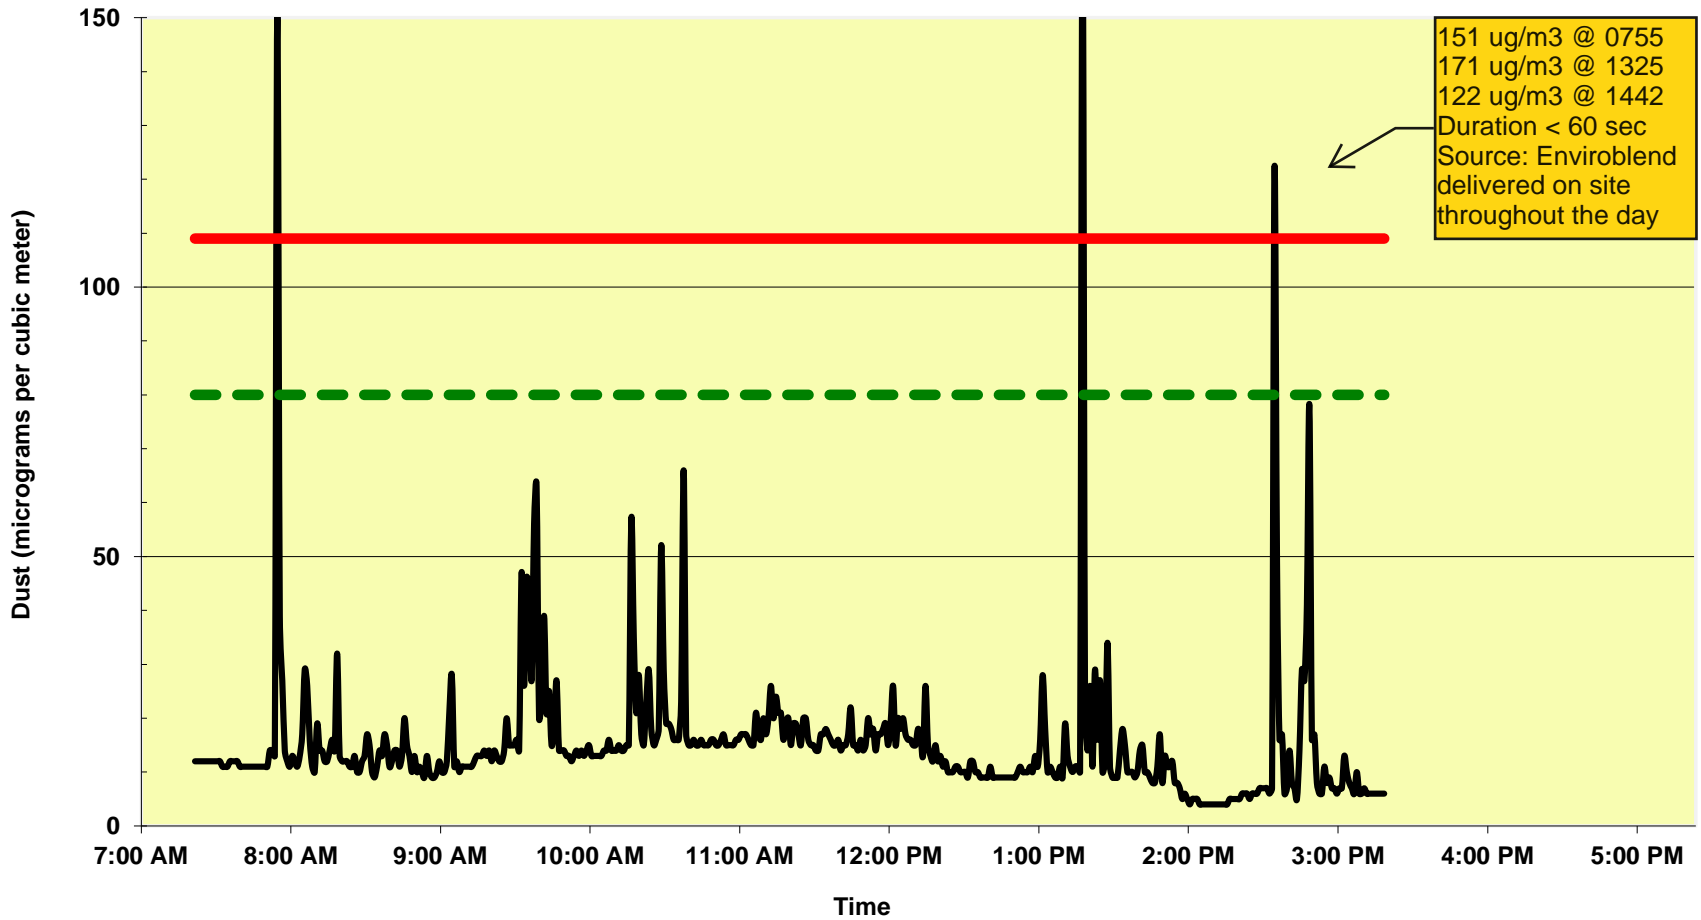
**Former Midland-Ross Site
Highland Park, New Jersey
Dust Monitoring Results
Air Monitor 5 8/22/2018**

Air Monitoring Results

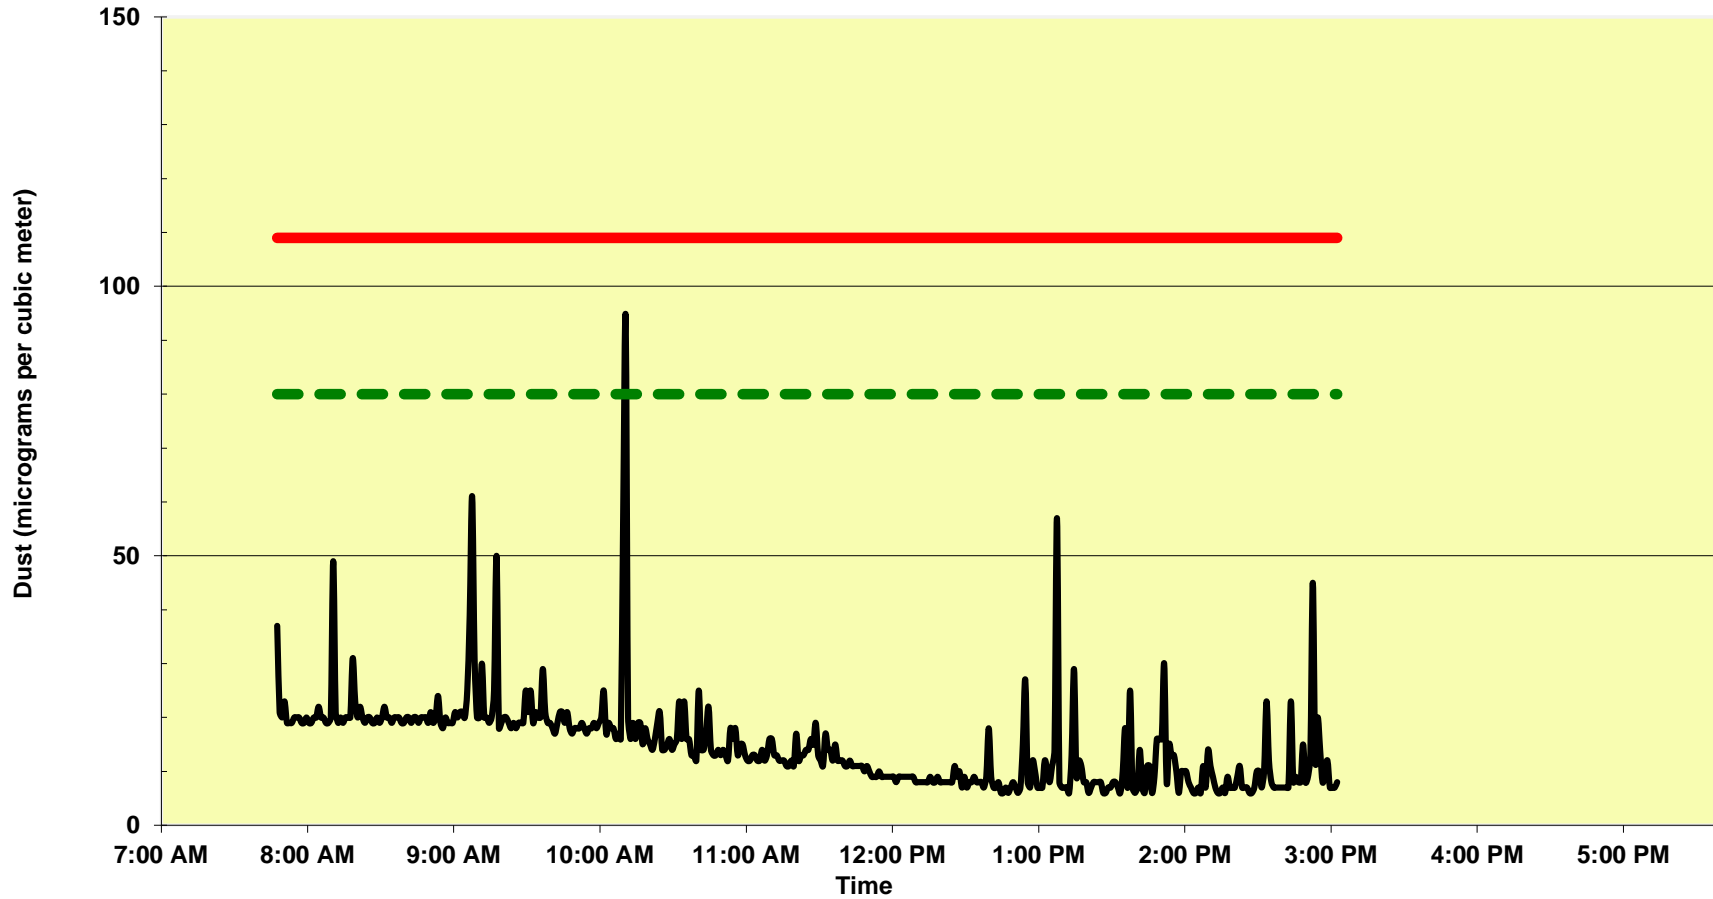
**Former Midland-Ross Site
Highland Park, New Jersey
Dust Monitoring Results
Air Monitor 1 8/23/2018**

Air Monitoring Results

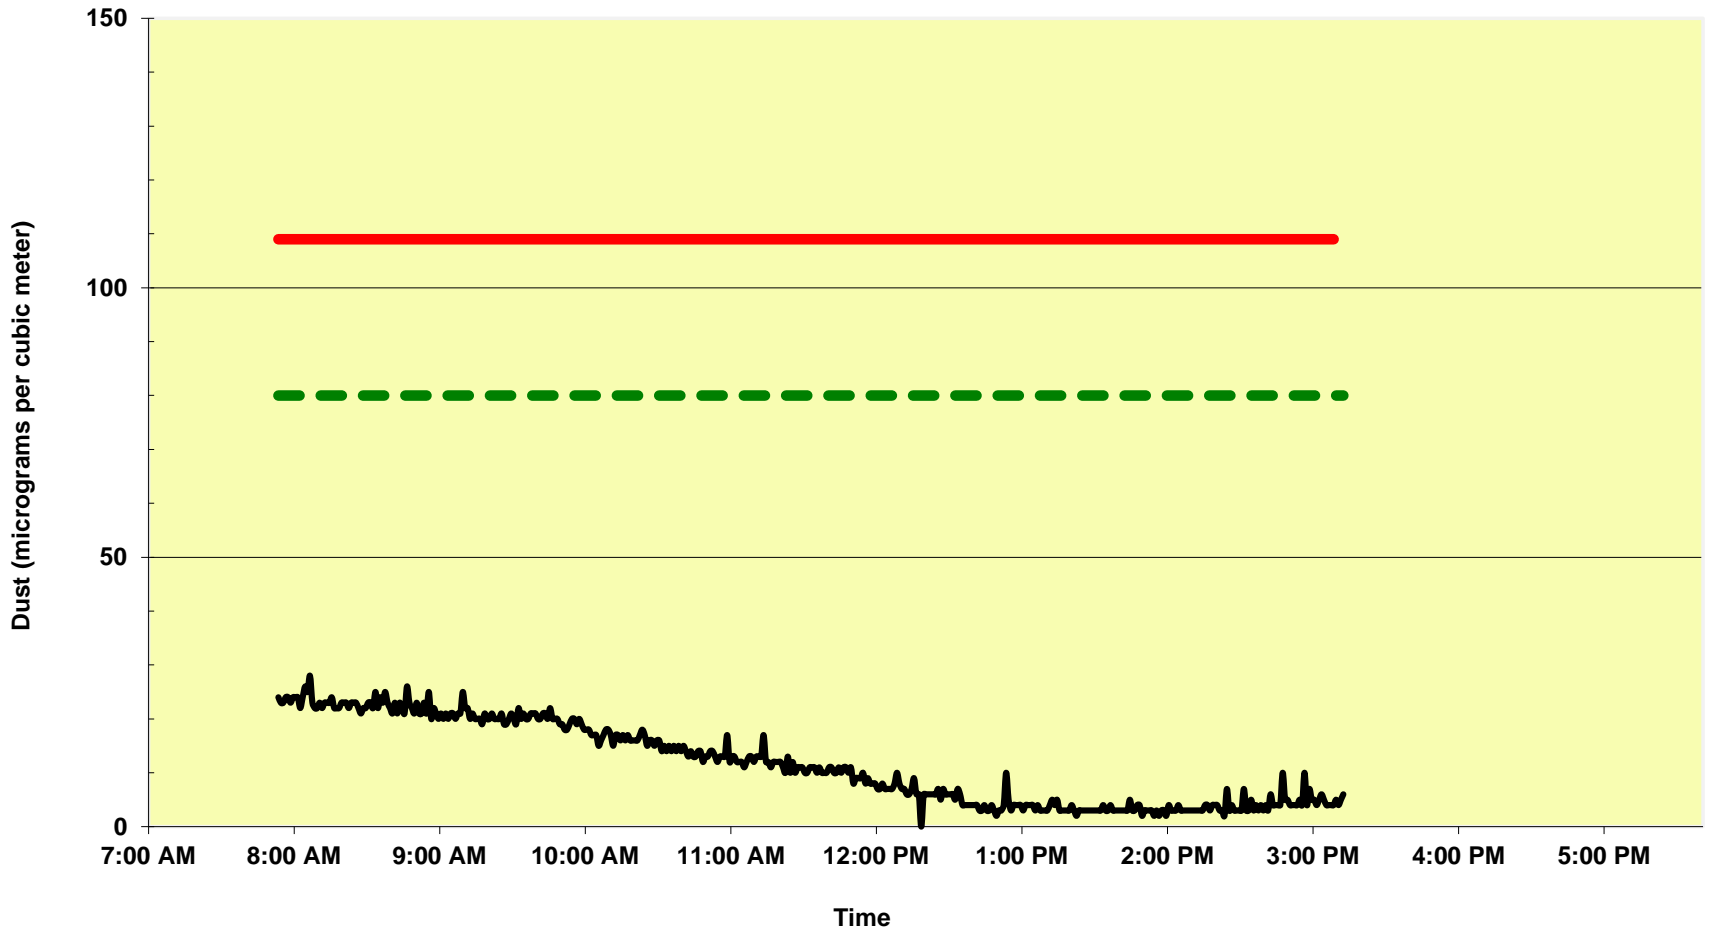
**Former Midland-Ross Site
Highland Park, New Jersey
Dust Monitoring Results
Air Monitor 2 8/23/2018**

Air Monitoring Results

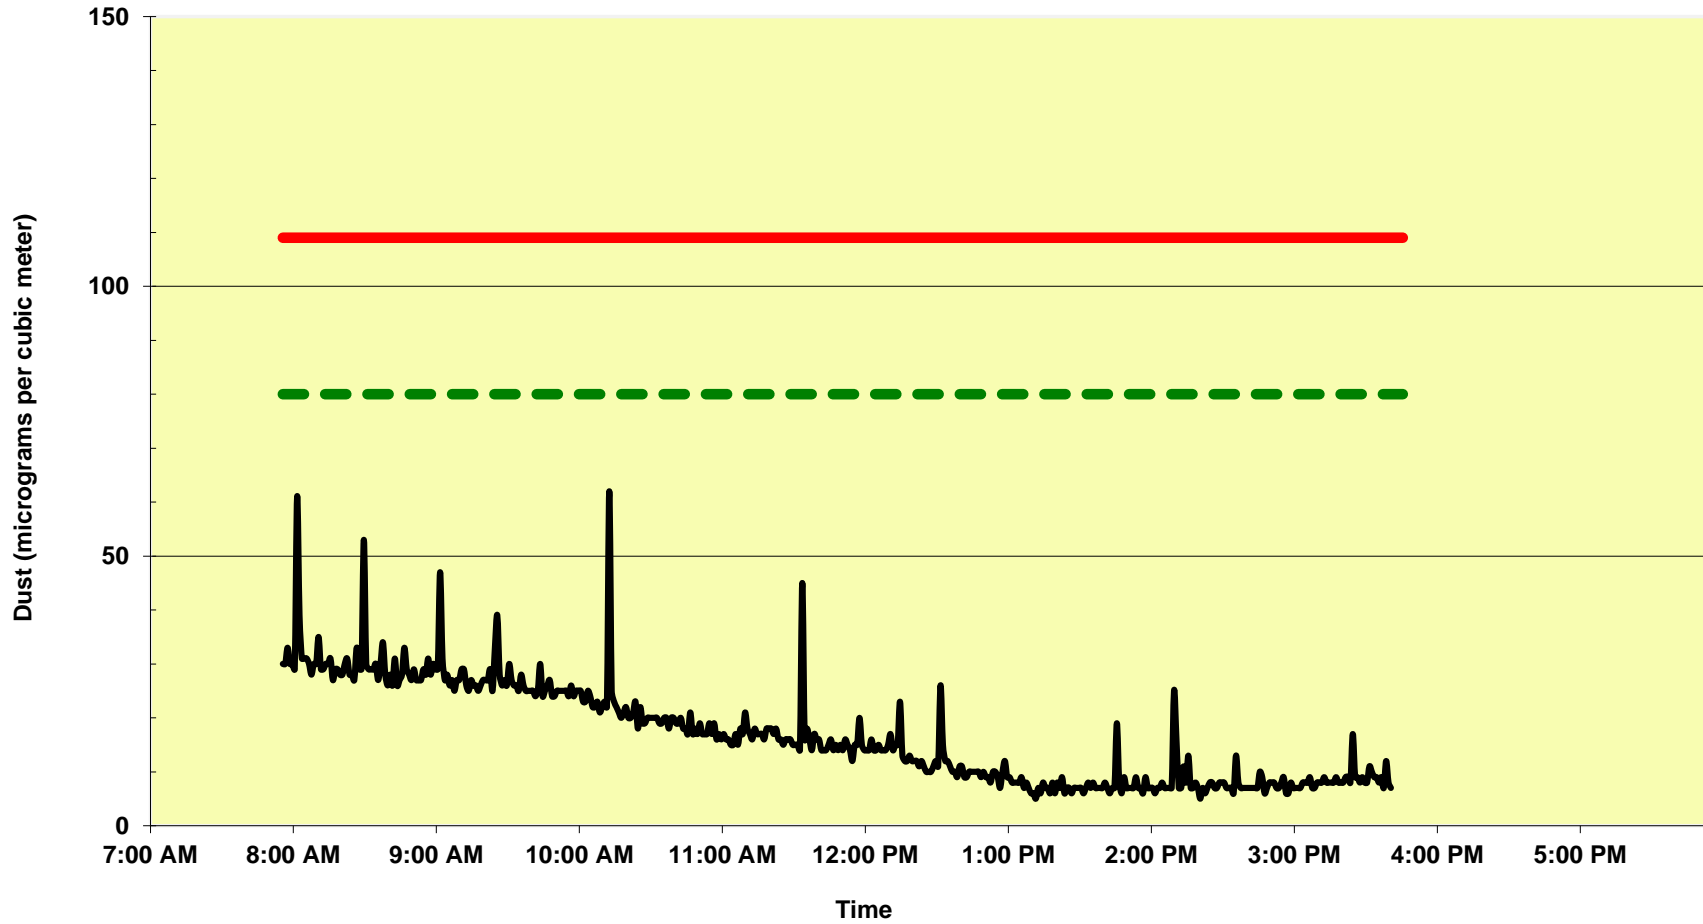
**Former Midland-Ross Site
Highland Park, New Jersey
Dust Monitoring Results
Air Monitor 3 8/23/2018**

Air Monitoring Results

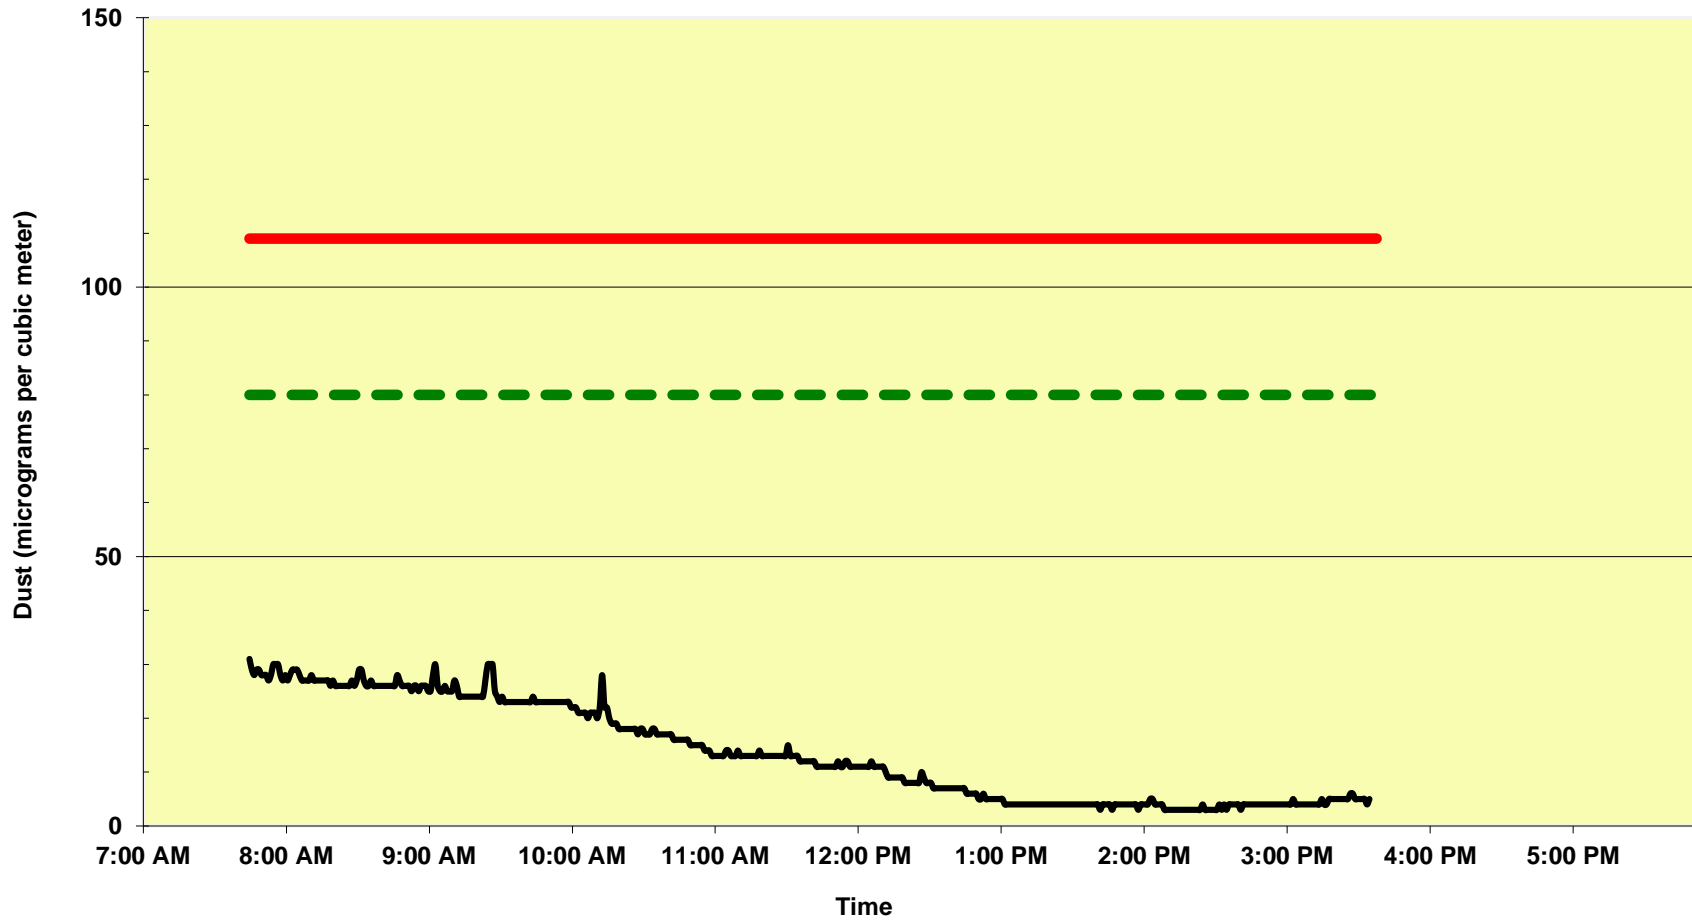
**Former Midland-Ross Site
Highland Park, New Jersey
Dust Monitoring Results
Air Monitor 4 8/23/2018**

Air Monitoring Results

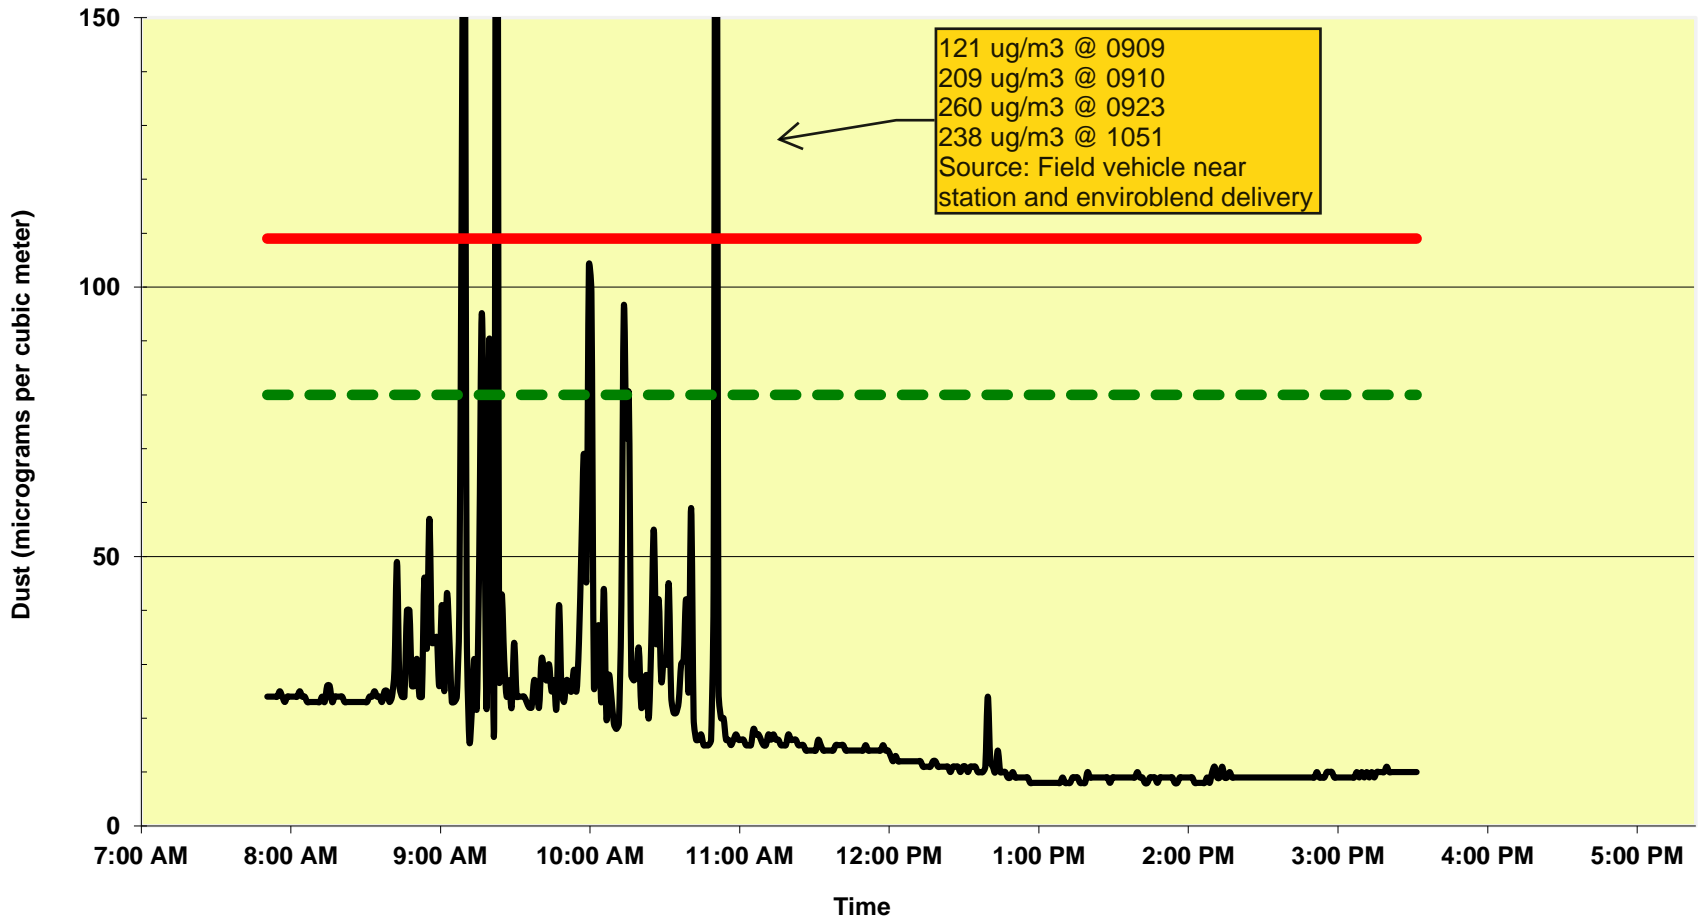
**Former Midland-Ross Site
Highland Park, New Jersey
Dust Monitoring Results
Air Monitor 5 8/23/2018**

Air Monitoring Results

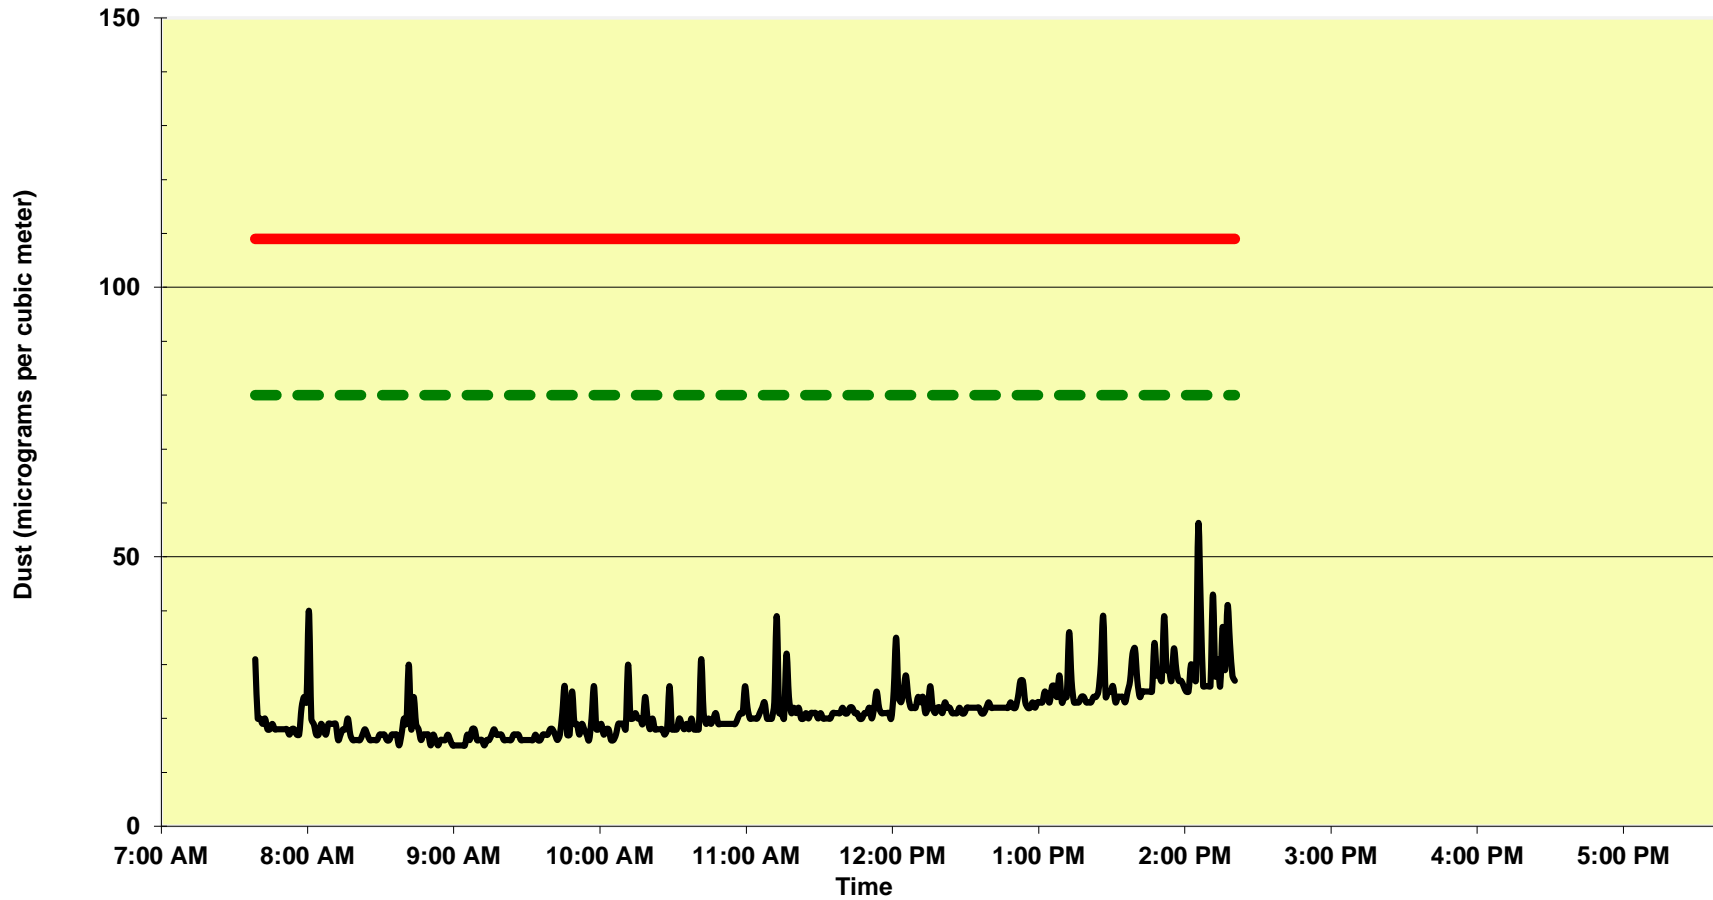
**Former Midland-Ross Site
Highland Park, New Jersey
Dust Monitoring Results
Air Monitor 1 8/24/2018**

Air Monitoring Results

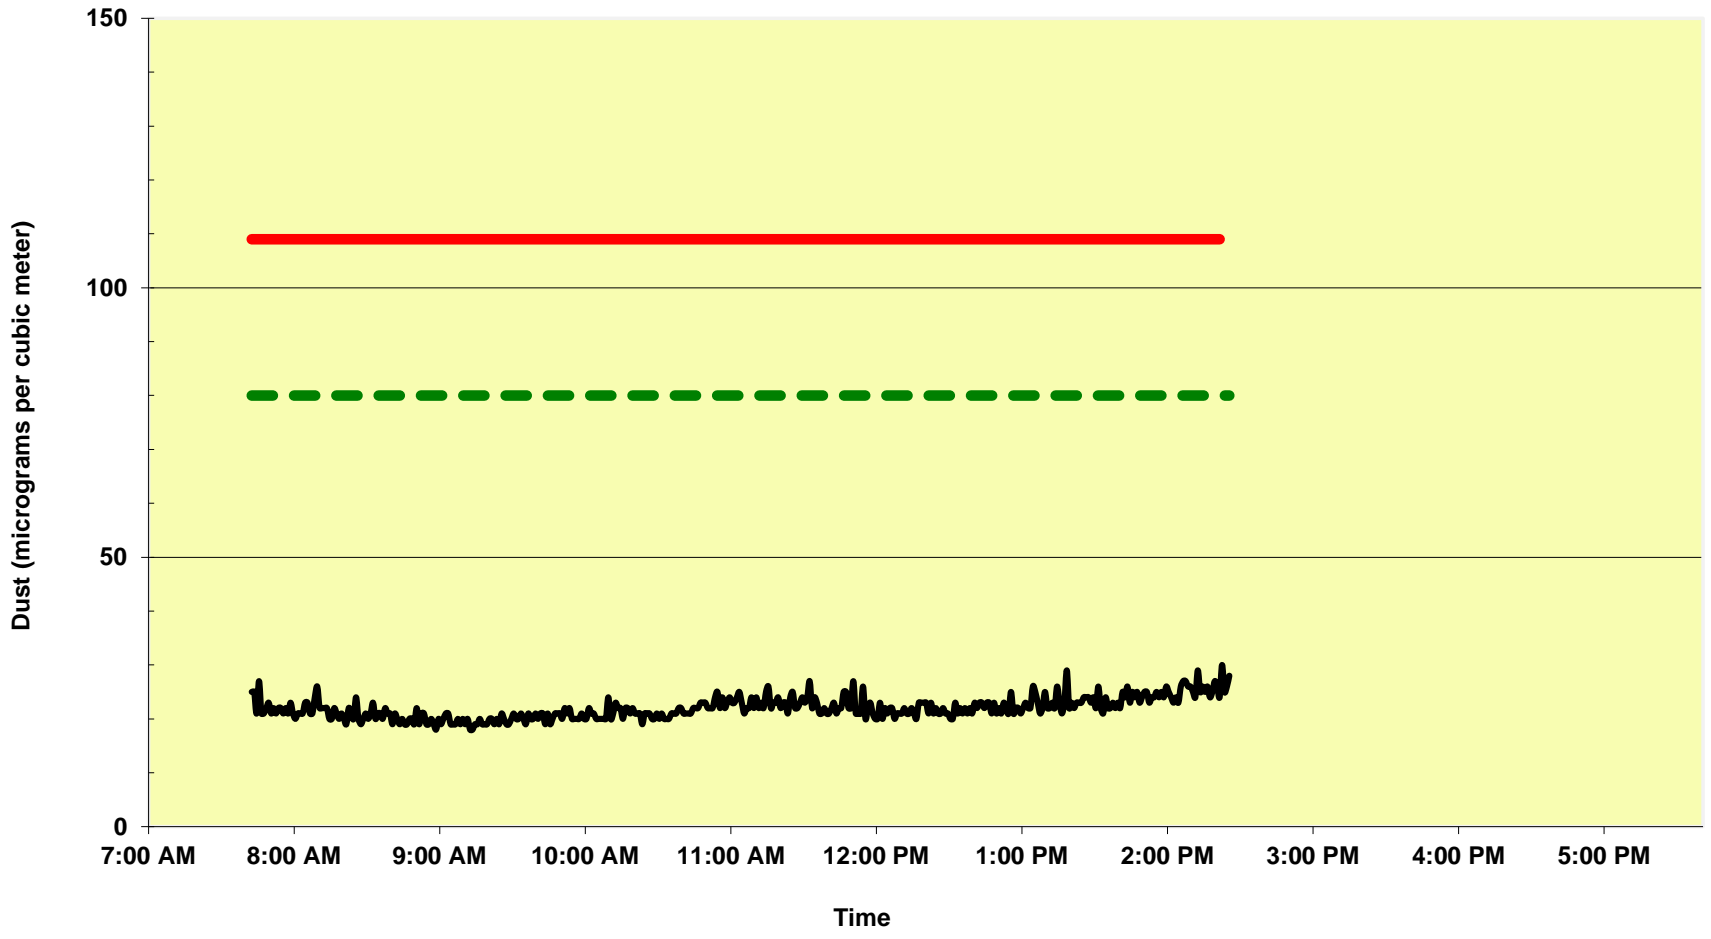
**Former Midland-Ross Site
Highland Park, New Jersey
Dust Monitoring Results
Air Monitor 2 8/24/2018**

Air Monitoring Results

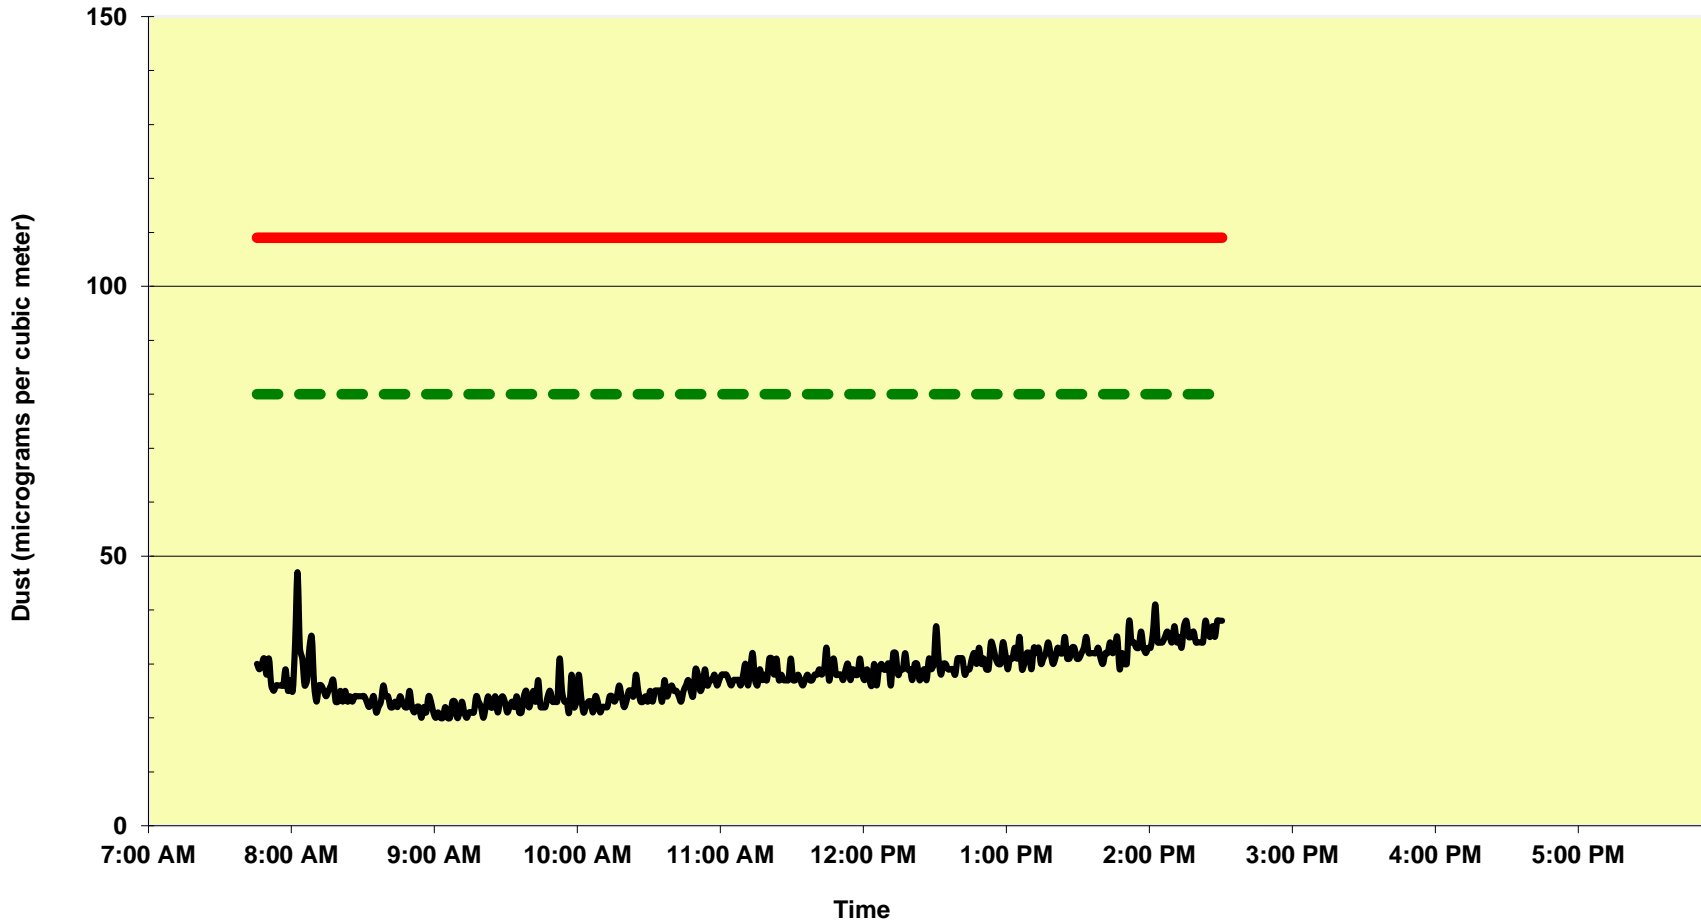
**Former Midland-Ross Site
Highland Park, New Jersey
Dust Monitoring Results
Air Monitor 3 8/24/2018**

Air Monitoring Results

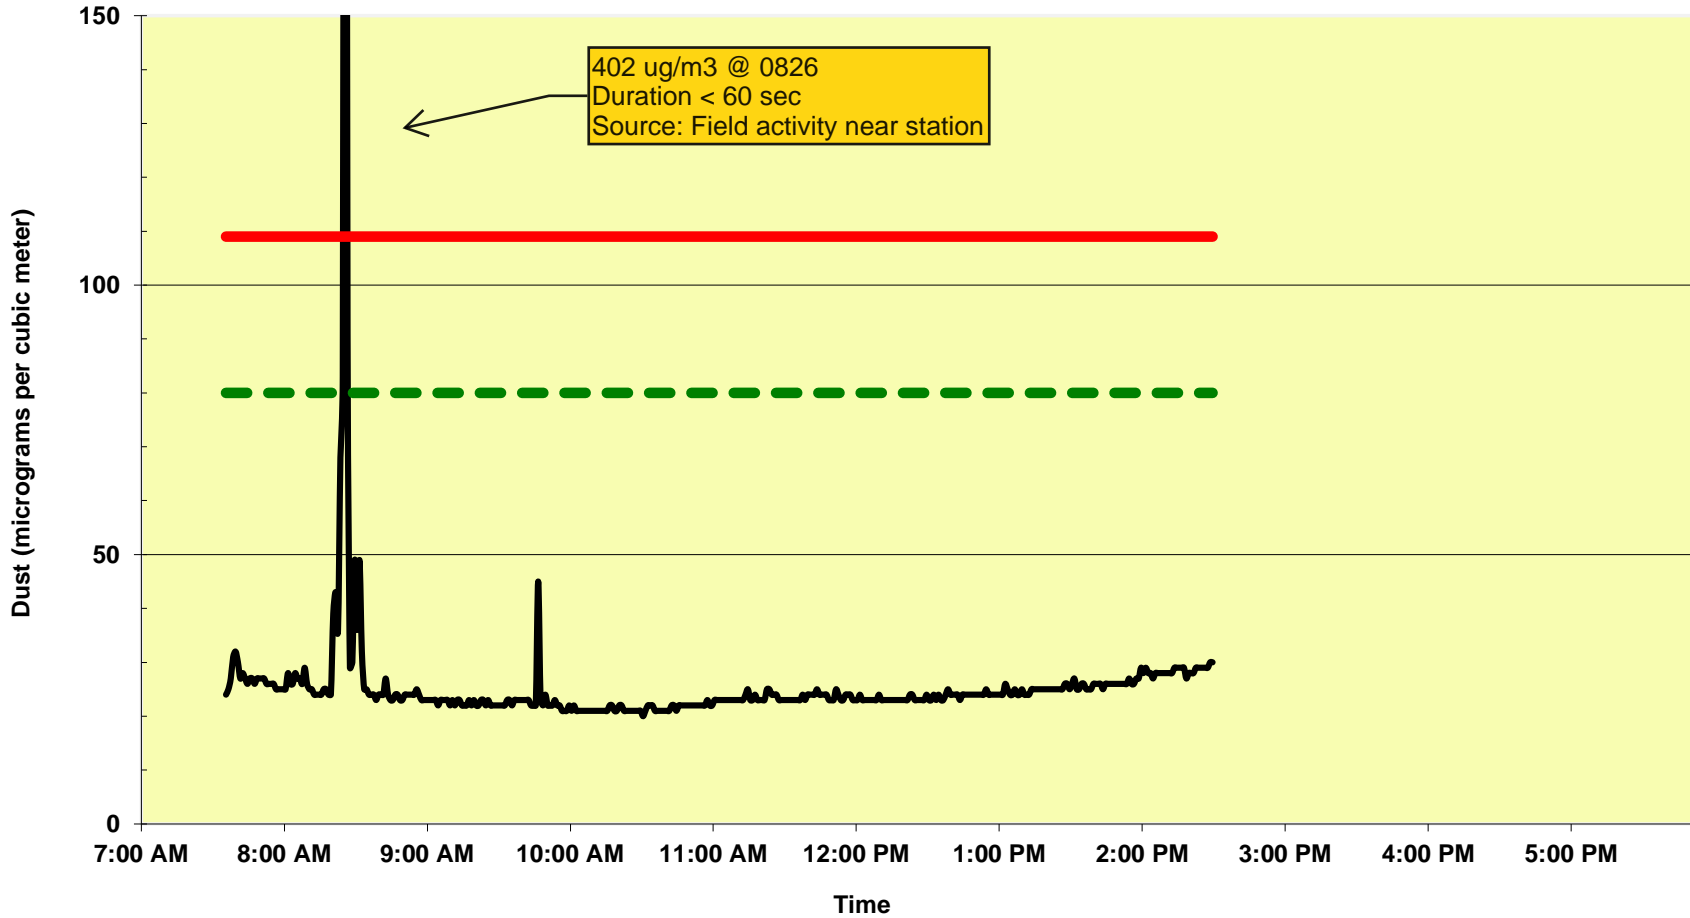
**Former Midland-Ross Site
Highland Park, New Jersey
Dust Monitoring Results
Air Monitor 4 8/24/2018**

Air Monitoring Results

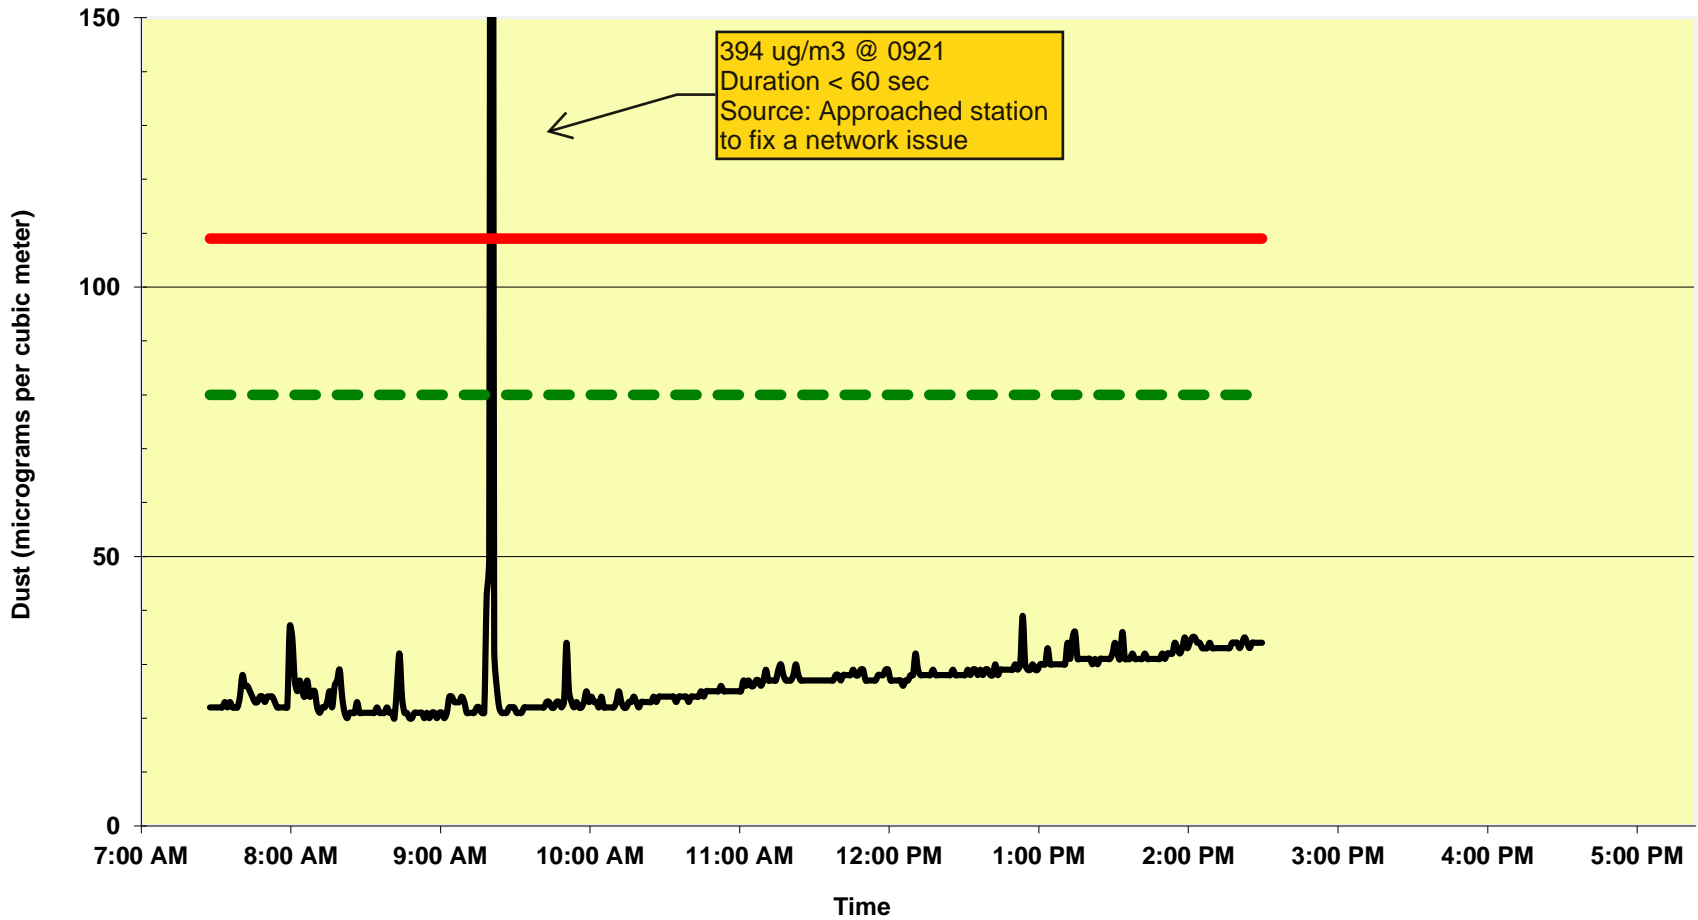
**Former Midland-Ross Site
Highland Park, New Jersey
Dust Monitoring Results
Air Monitor 5 8/24/2018**

Air Monitoring Results
